**TECHNICAL ASSISTANCE
IN THE MANUFACTURE AND
QUALITY CONTROL OF THE
AID/BATTELLE HANDPUMP IN THE
DOMINICAN REPUBLIC**

WASH FIELD REPORT NO. 20

JUNE 1981

Prepared by:
Robert Knight
Consultant

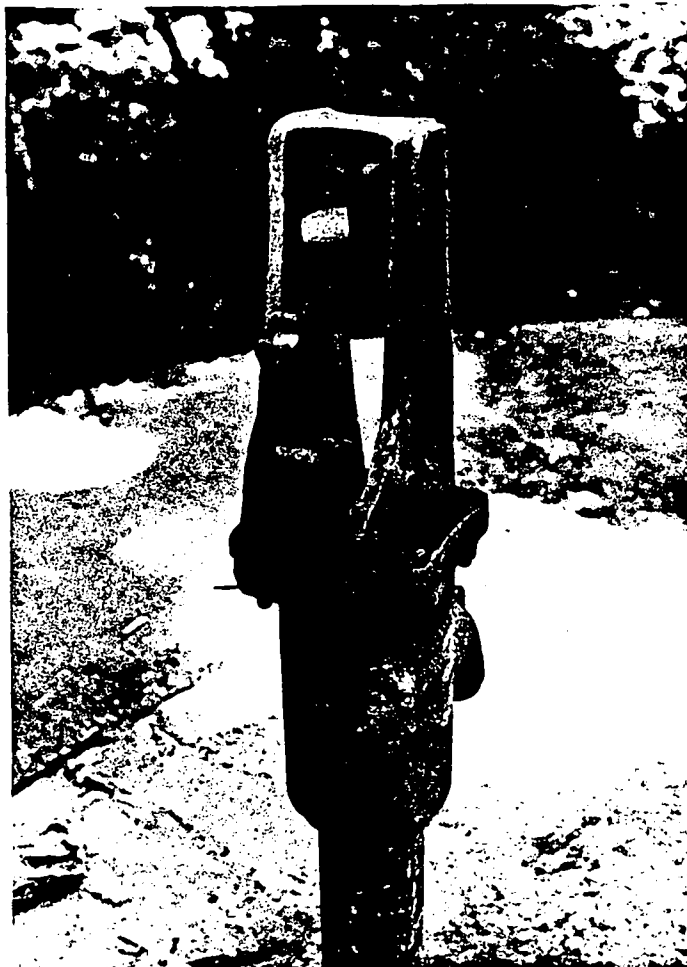
In February 1981 another field trip was made to La Vega, the site of the pilot project of 1978. The first stop was in Guaco where on a previous visit an AID pump was found to have a badly worn handle pivot pin and an almost nonexistent bush. This time the pump was not operational. The problem was not due to the pin, as might be expected, but was caused by a broken fulcrum link (Plate 2). It was reassuring to learn that this was not a design problem, but due

PLATE 2: Broken fulcrum link (Guaco).

to a void in the casting. It was possible to install a new fulcrum while there, but the replacement handle did not fit into the pump cap because the parts were not standardized. This needs investigating. In addition, the plunger fell apart because of a stripped screw thread. It was possible to reassemble the unit by removing one of the leather cups and matching up two good portions of the thread.

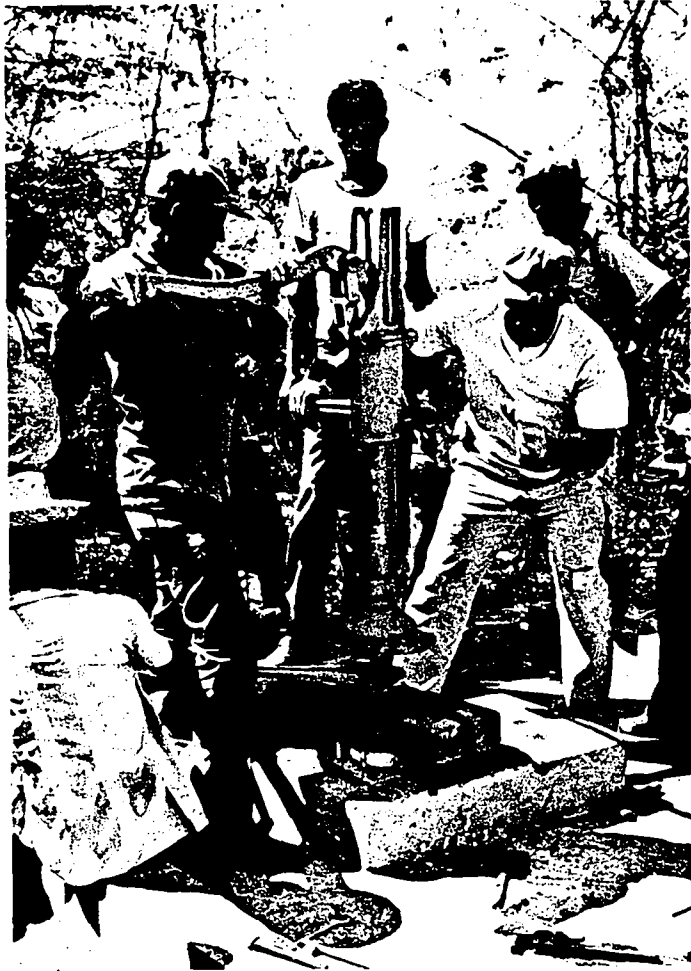
Next day we made another field trip, this time it was to Azua. The first well site visited was at El Barro. We arrived in time to see the pump being installed (Plate 3). It was evident that the concrete was of inferior quality. The hold-down bolts used to mount the pump had a tendency to crack the concrete base when the nuts were tightened. There may have been two factors causing this: one, there had not been enough time for the new concrete to cure; and, two, the sandy appearance of the slab suggested that not enough cement was being used in the concrete mixture. This well was 95 feet deep with a three inch cylinder. Although the water came readily, considerable force was required on the pump handle. Perhaps the two inch cylinder of the future modified pump will relieve this problem with the deeper wells.

PLATE 3: Pump being installed at El Barro.

Another problem is that of the hold-down bolts turning in the concrete. This can create a great problem when the pump has to be removed. A partial solution would be to tamp the fresh concrete around the area of the bolt heads with a thin tamping rod. This would tend to fill any voids in the concrete in the proximity of the hexagon heads. Hexagon head bolts, however, are not the recommended things to use for this purpose. There is such a thing as a "J" bolt, so named because of its shape. The advantages of a bolt of this shape can readily be seen when embedded in concrete. It will not turn, and it cannot easily be pulled out.

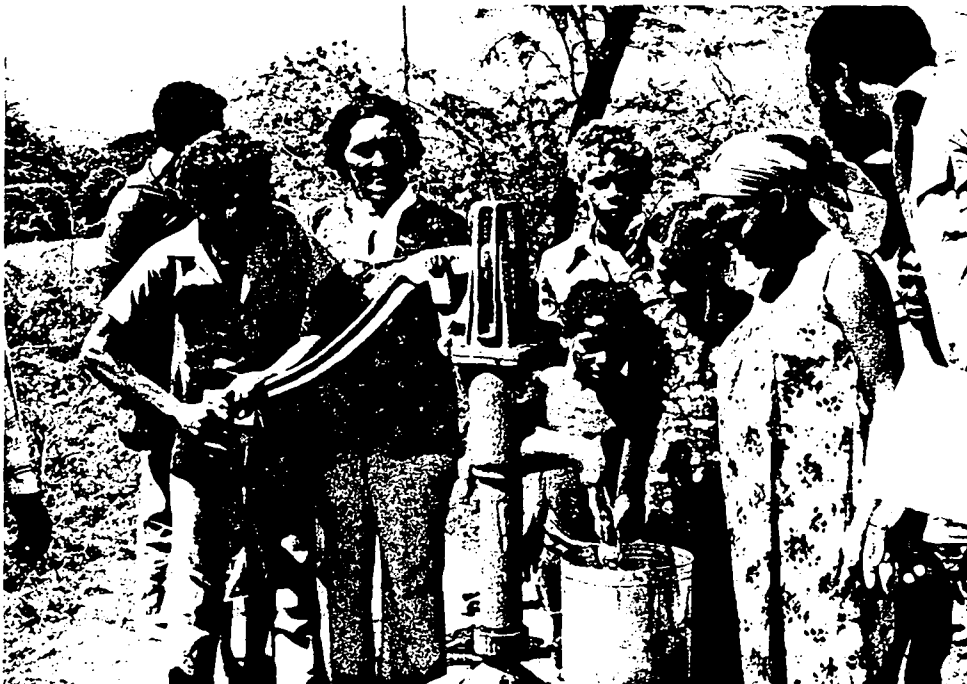
Next stop was El Medio for another installation. I had the opportunity to test an all-PVC deep well cylinder with a PVC check valve which I had prepared in Maryland. I had the new cylinder installed with the approval of the SESPAS engineers who were present. The pump worked well and feedback is anticipated on the performance of the cylinder. This well is around 65 feet deep. While we were there a woman and a child each operated the pump (Plate 4). Pumping was relatively easy. It should also be noted that prior to this installation the villagers had to walk two kilometers to the river for water.

PLATE 4: New installation at El Medio.

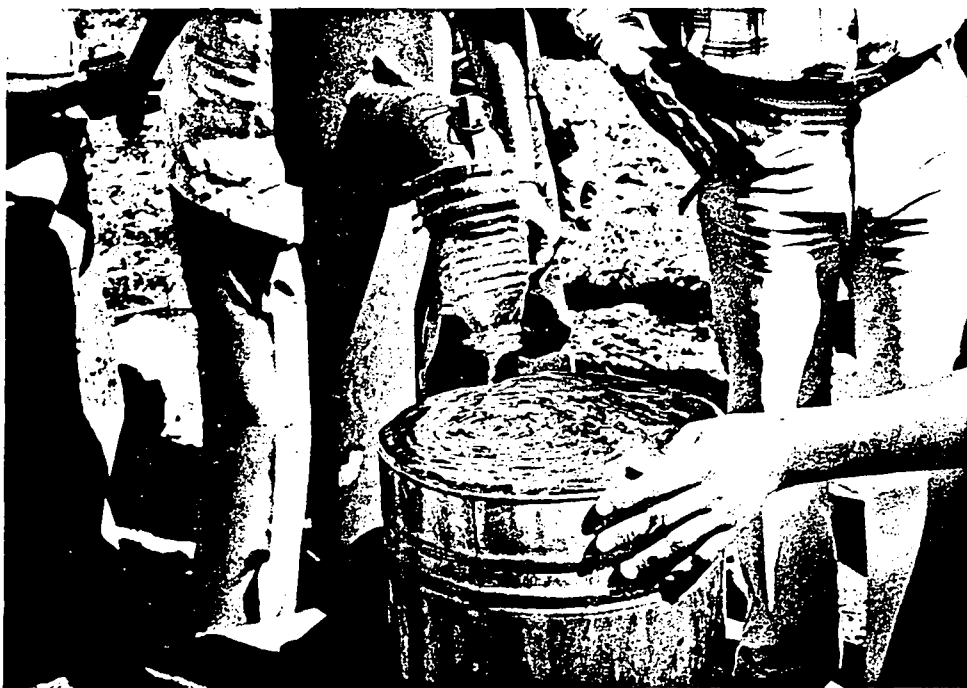
PLATE 5: Locally modified outlet—Intended to facilitate filling small mouthed water containers (Iguarto).

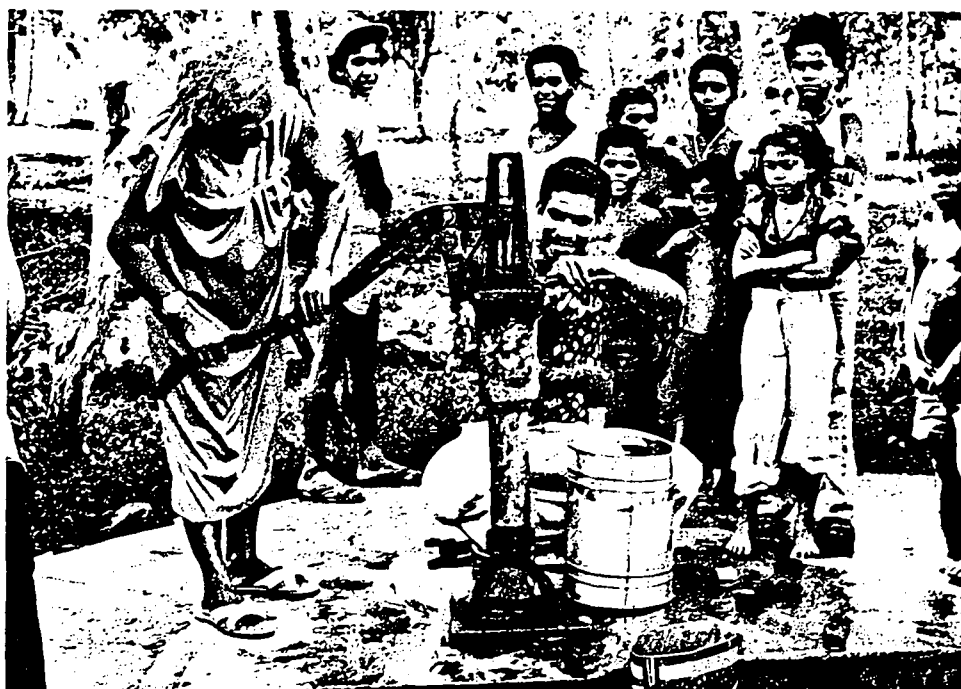
PLATE 6: The pump at Guaco after replacement parts had been installed.

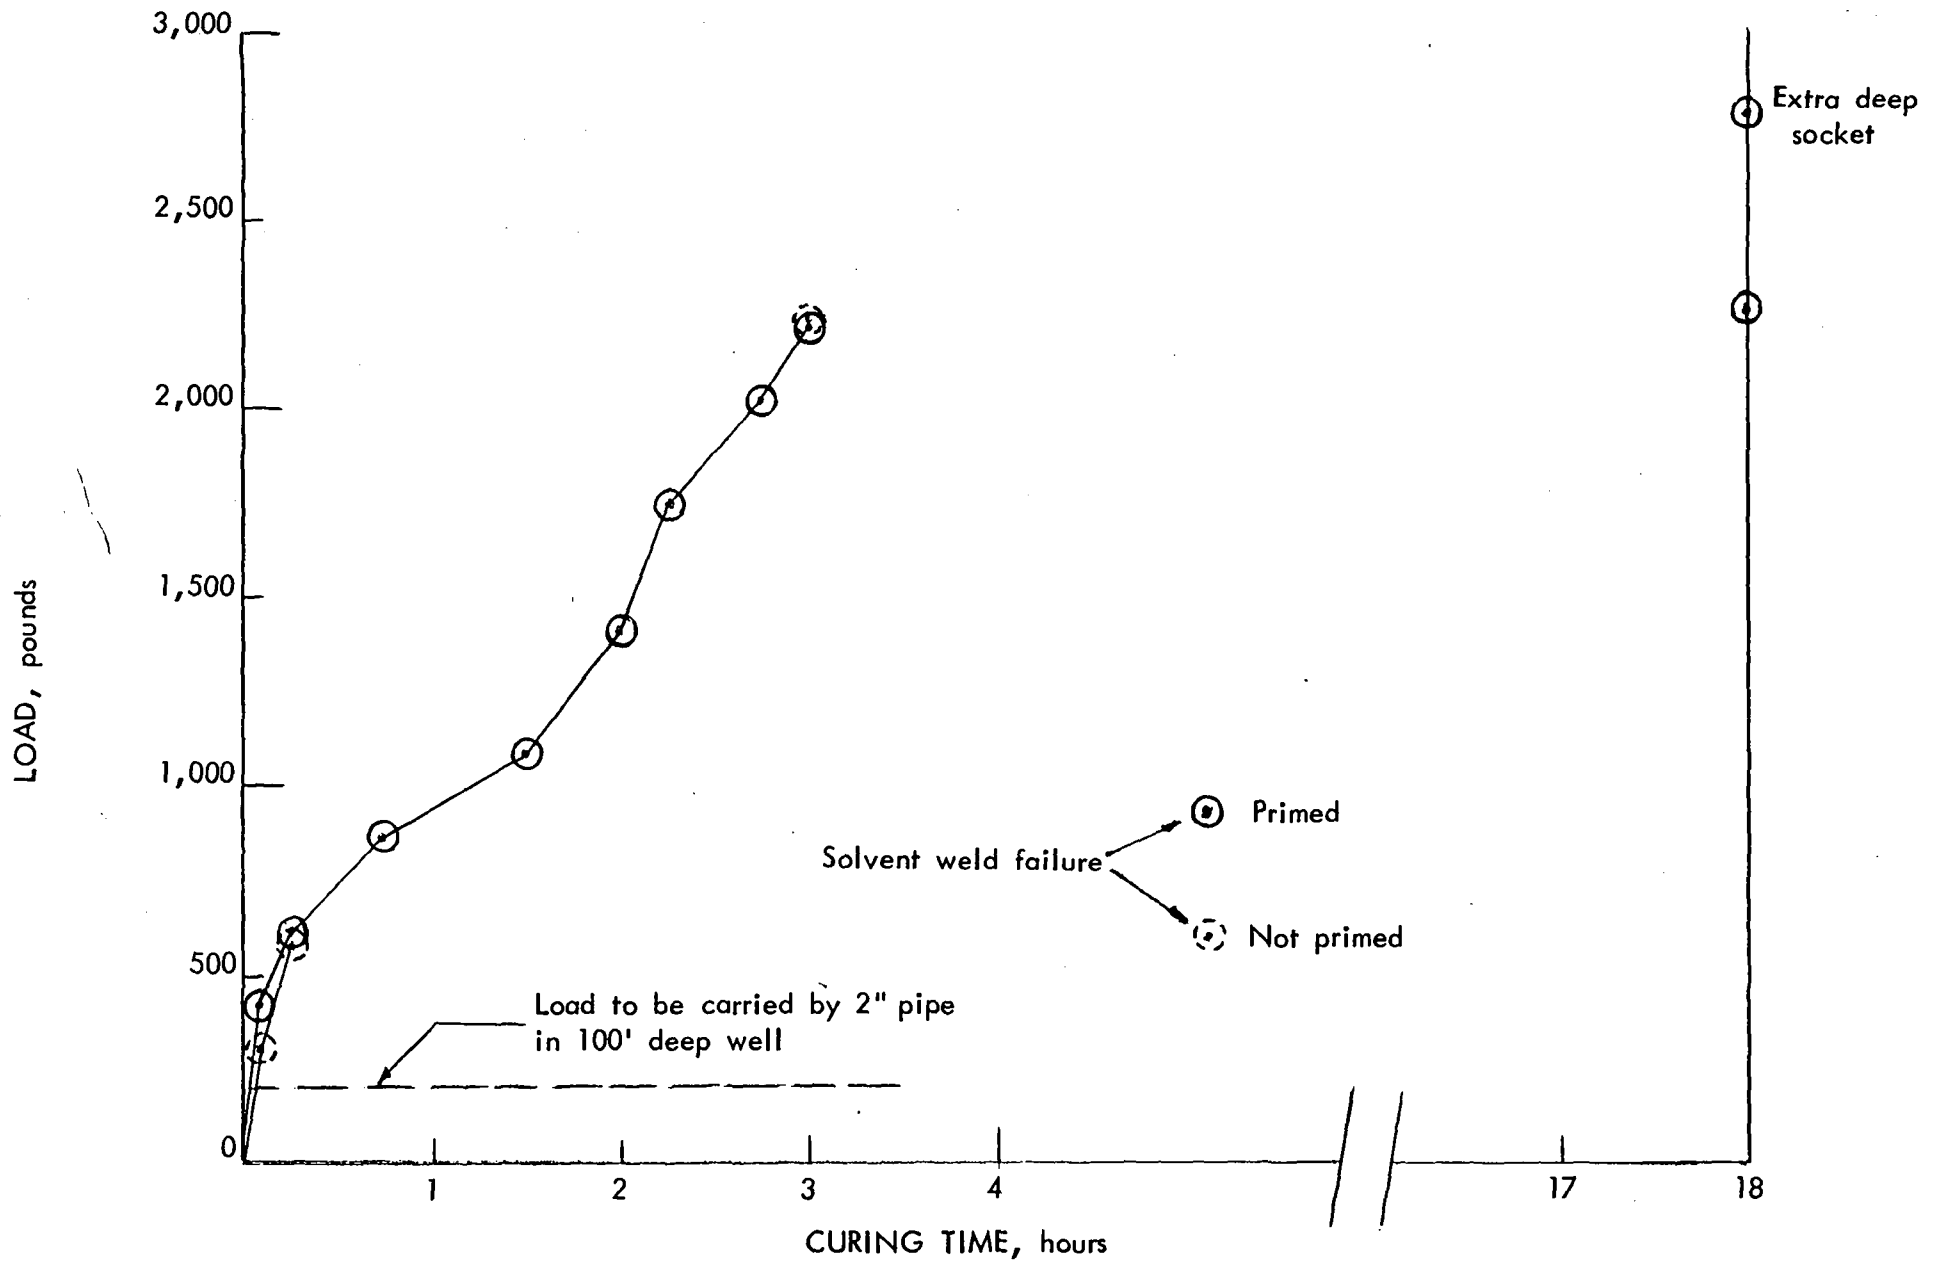
Figure 2
Load Tests on Solvent Welded PVC Pipes and Adaptors

Some were cleaned and primed before the cement was applied. Some were cemented without preparation. Referring to Figure 2, it appears that priming the joint surfaces is most critical during the first few minutes. At the three-hour mark, the points on the curve for the primed and the not-primed almost coincide. Only four un-primed specimens were tested for comparative results and two of them failed very quickly. It is intended that all joints be properly prepared during field installations.
