WAVIN HANDPUMP

#### INTRODUCTION

This is the second of two reports on laboratory testing of the Wavin handpump. The earlier report, ref: A9113, dealt with inspection, a design assessment, a series of pump performance tests and a handle bump stop test. This consolidated report incorporates A9113 and also describes the results of a 4000 hour endurance test, followed by tests of pump performance after endurance, side impact tests and an engineering review.

#### Wavin Handpump

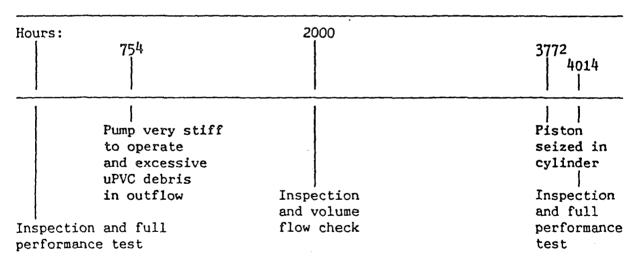
#### 7.2 Breakdown Incidence

The pump did not break during the endurance test. However, there were a number of breakdowns, caused by the pump seizing when particles of uPVC lodged between the piston seal and the cylinder. In the first failure,

Breakdowns are shown in bold type
