**India Mark II Hand Pumps
with Open Top Cylinders
in Low Lift Application**

**Maintenance Data Analysis
from 1986 till March, 1992.**

Raj Kumar Daw
Danida Project Directorate
Bhubaneshwar, Orissa

May, 1992

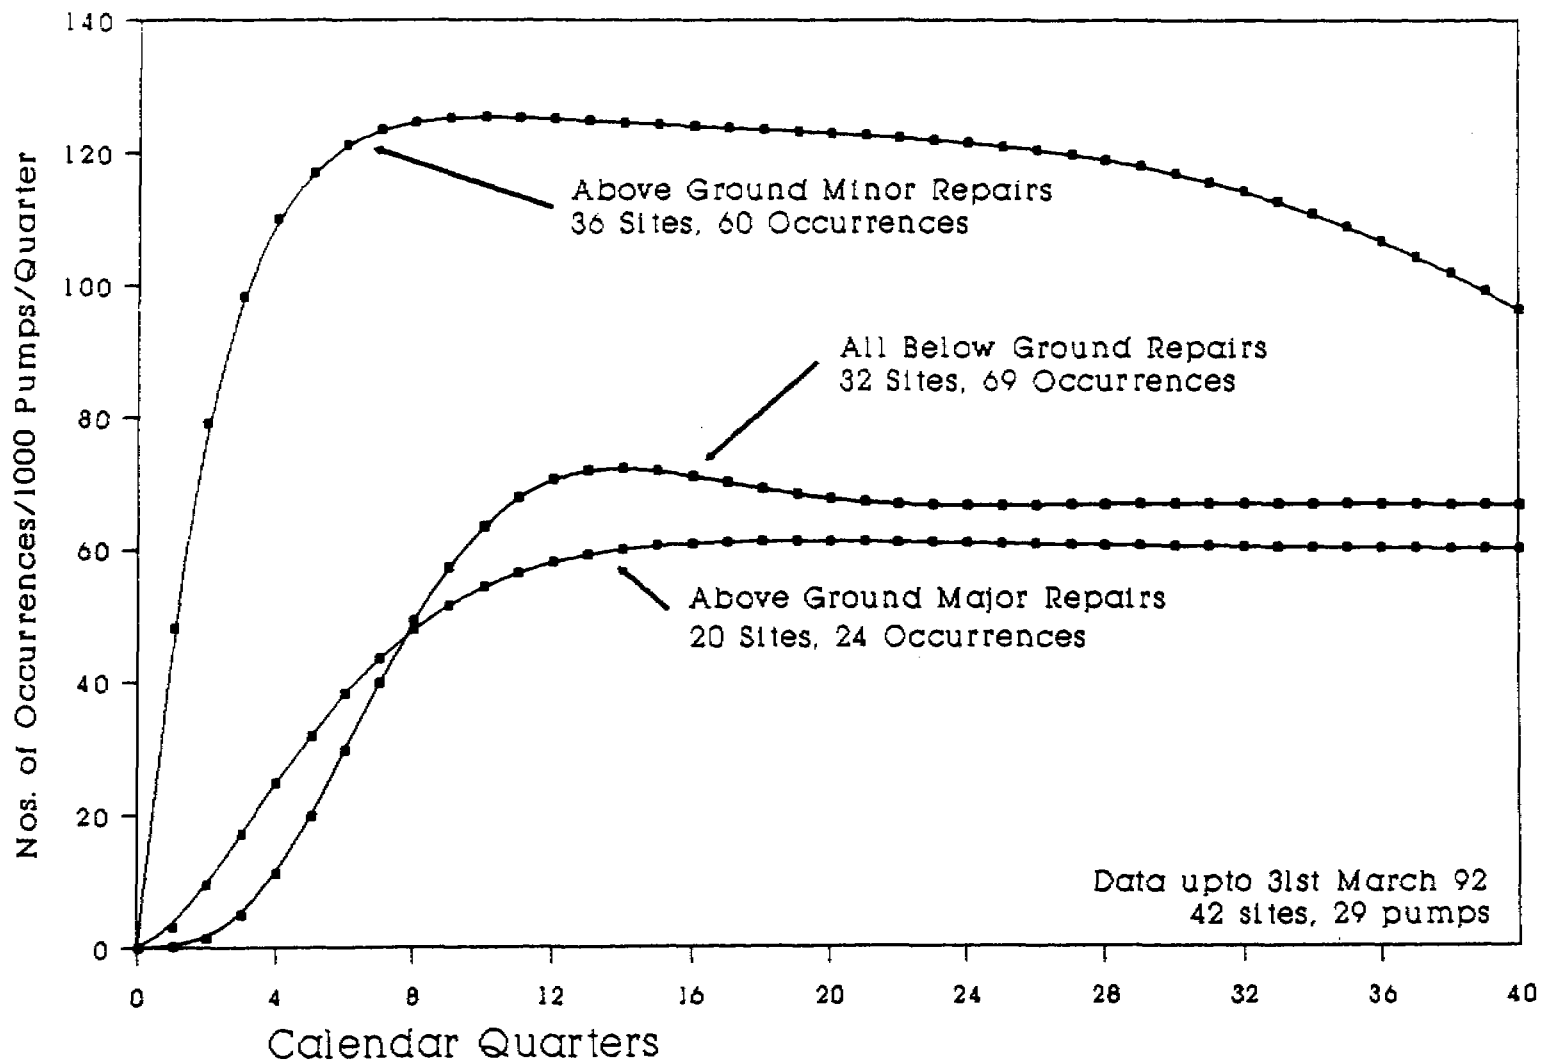
Major & Minor Above Ground and Below Ground Repairs

1. **Major & Minor Above Ground and Below Gound Maintenance** : This graph gives the comparison between the three maintenance categories. As is evident from the graph, Above Ground Minor Repairs have a much higher rate of occurrence than Above Ground Major or Below Ground Repairs.

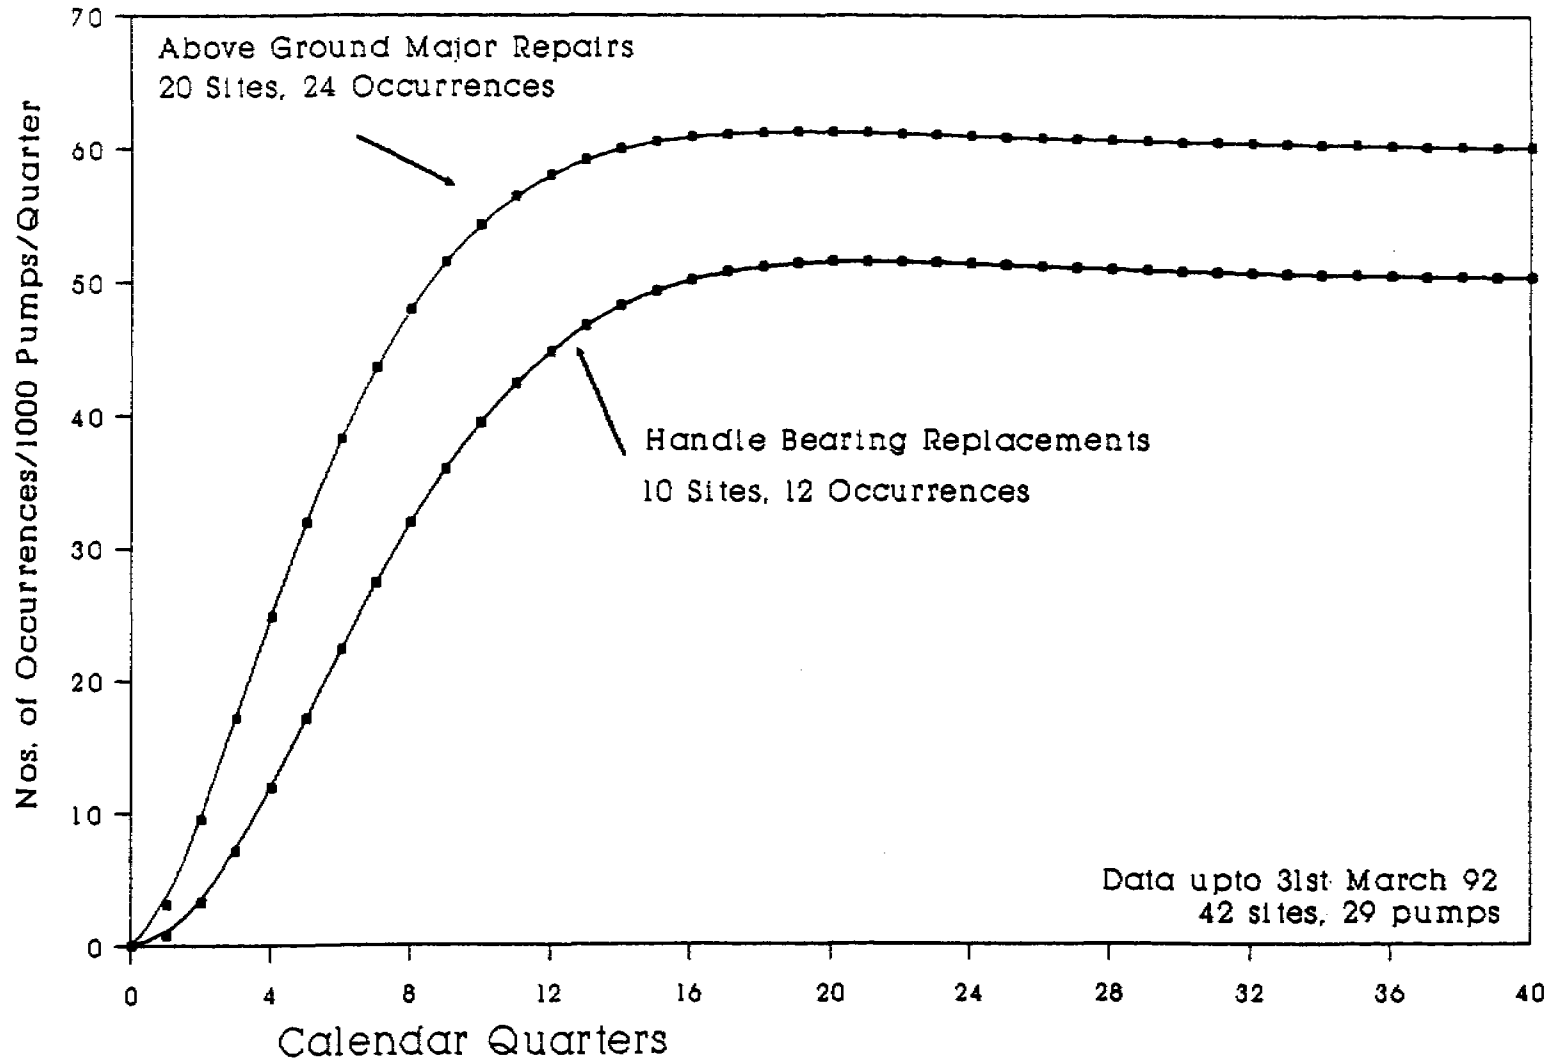
Major Above Ground Repairs & Bearing Replacements

2. **Major Above Ground Repairs & Bearing Replacements** : In major above ground repairs since handle bearing repairs constitute the most important component, the occurrence of these two have been compared. As expected, their occurrence patterns are very similar.

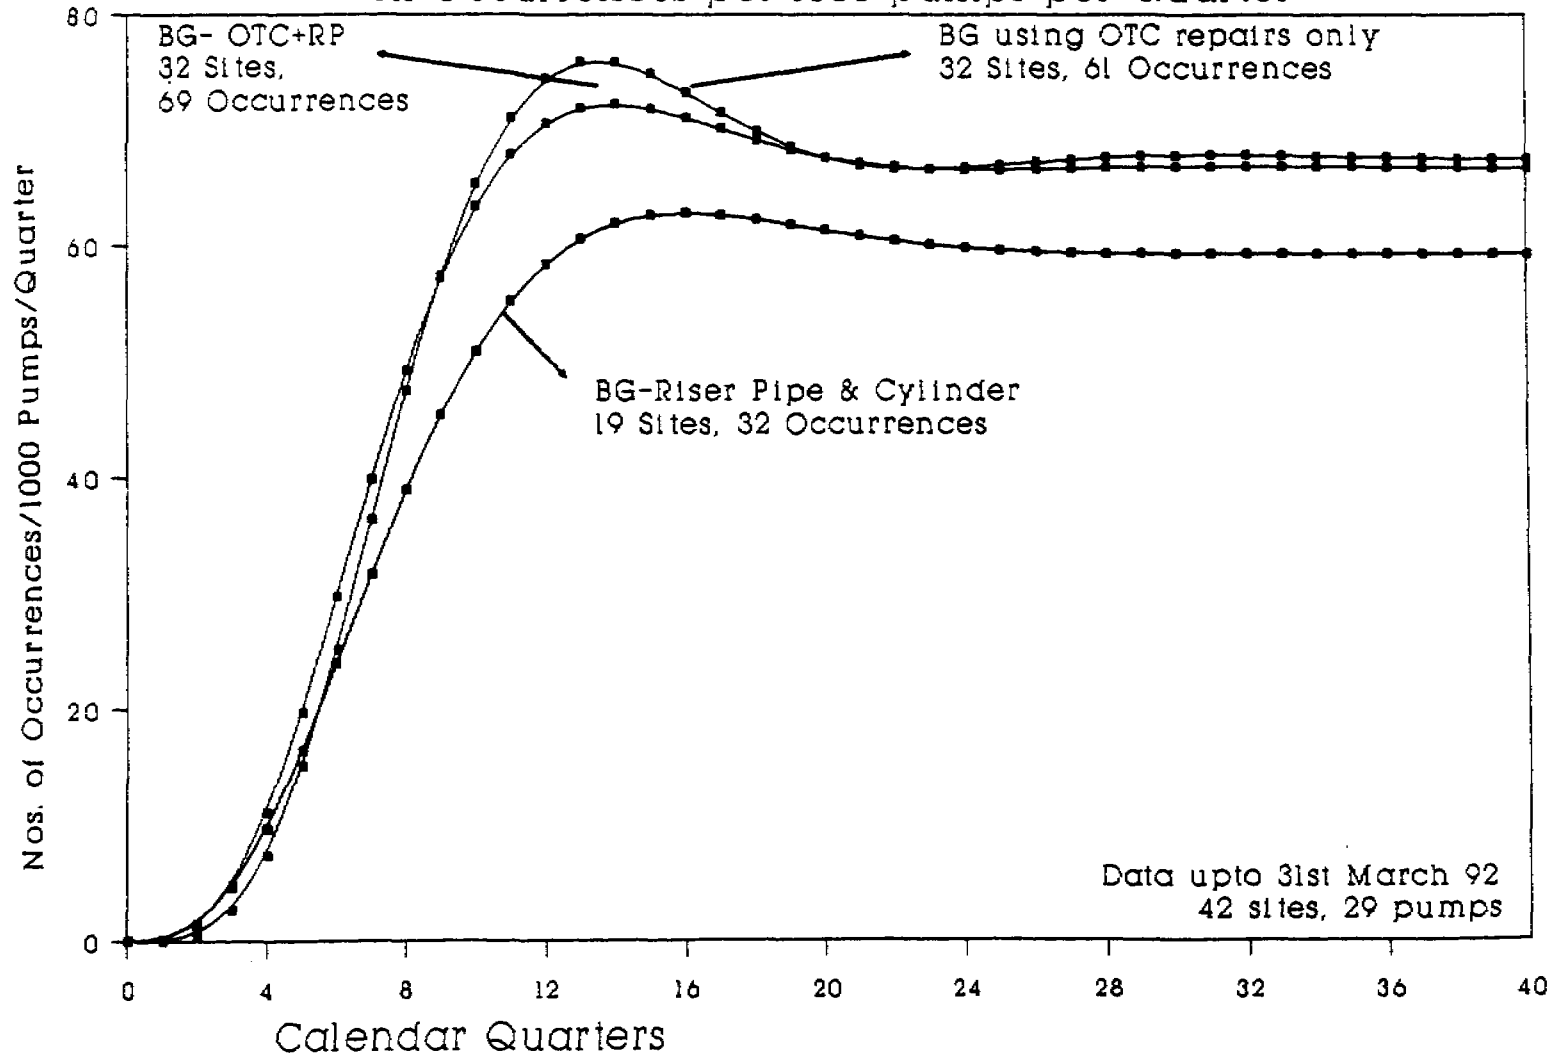
Below Ground Repairs in Occurrences per 1000 pumps per Quarter

3. **Below Ground Repairs** : Below ground repairs limited to riser pipe and cylinder interventions would require removal of the riser pipe assembly. Other below ground repairs, of the rod, cup washers, upper valve and lower valve (including 'O' ring) would have used the OTC system. These two types of occurrences, i.e., BG-RP and BG-OTC have been compared with all-BG interventions. All three graphs show similar patterns, BG-OTC is much closer to all-BG and BG-RP is lower. All these indicate consistency in the data.

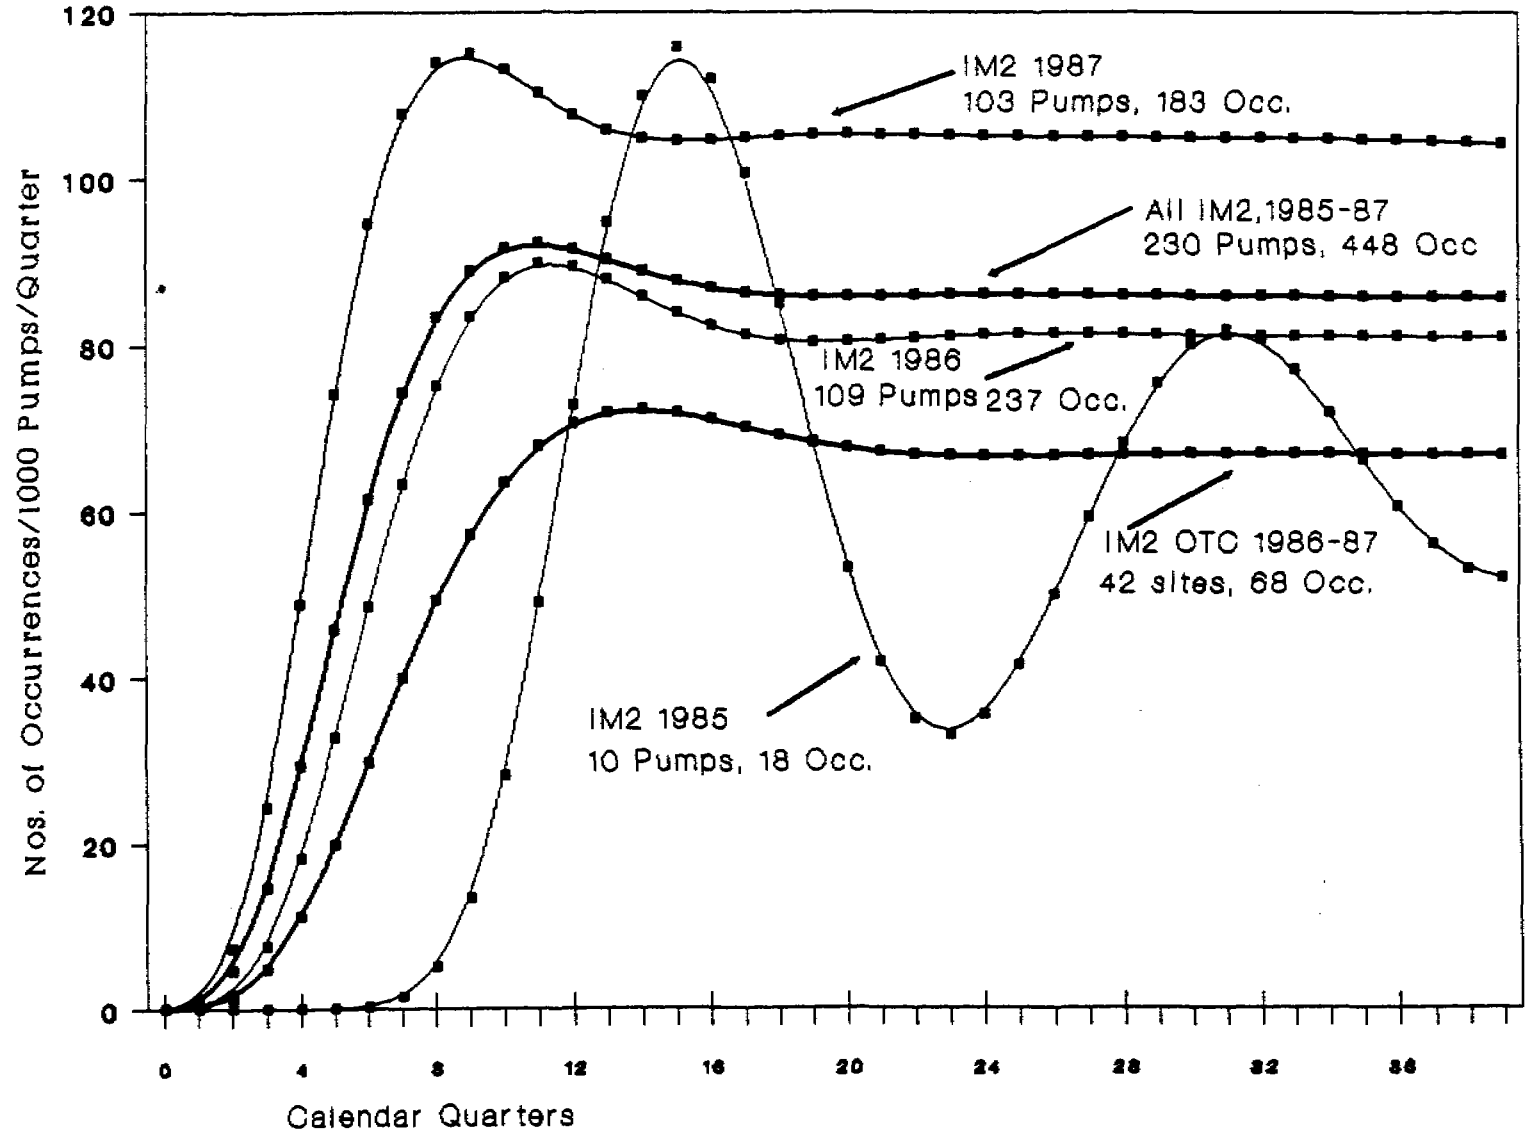
Below Ground Maintenance Needs - Comparision between IM2 & IM2 OTC LL

4. **Below Ground Maintenance Needs - Comparison between IM2 and IM2 OTC I.L.** : In this graph, data on a group of IM2 deep well pumps is compared with the IM2 OTC group for below ground maintenance occurrences. For the IM2 DW group, behaviour of installations of 1985, 86, and 87 have been presented separately. The "All IM2, 1985-87" curve then provides a basis for comparison with the IM2 OTC installations. As can be seen, the "All IM2" curve and "IM 2 OTC" curve are very similar in nature. The lower position of the OTC curve is a clear indication of its generally lower below ground maintenance occurrence.
