ENDURANCE TESTS OF ROBOVALVES

WASH FIELD REPORT NO. 102

SEPTEMBER 1983

Yaron M. Sternberg
and
Robert Knight

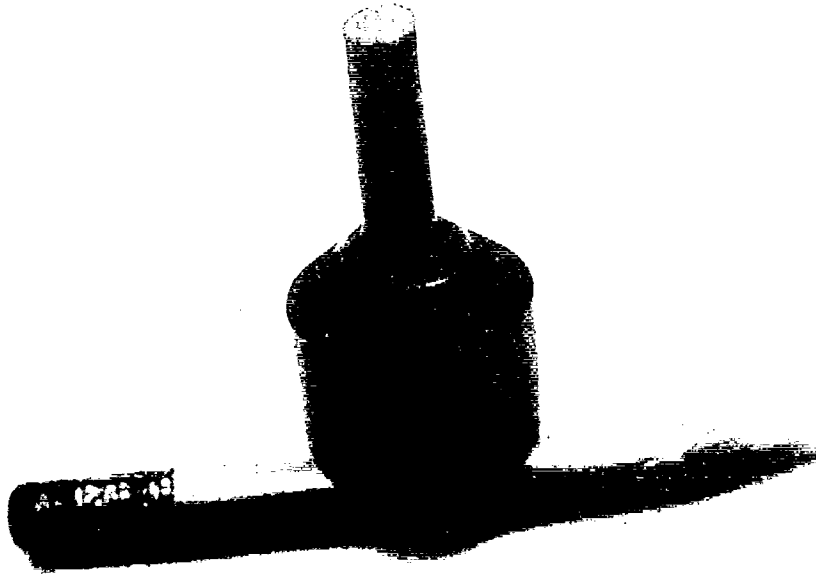
Four valves from each bank were selected for detailed examination. The long term leakage test data were used to select two leaking and two nonleaking specimens. Each valve was cut open and was carefully inspected with a magnifying lens. Subsequently, each float valve was inspected with a low power microscope specifically calibrated to measure wear. The original sloping surface of the cone was taken as the unworn surface, and the depth of the worn ring, i.e., depression, was measured. The cone was rotated so that the maximum and minimum wear was noted as well as the limits of the width of the ring. The surface condition of the ring, i.e., finish, was also noted as well as other features. Examples of a worn float valve and valve seats are shown in Figures 4-9. A summary of the wear data is given in Table 10. Analysis of the data did not indicate any discernable wear pattern. For example, it was expected that the magnitude of the depression in the valves subjected to high pressure would be more pronounced than that in the valves subjected to lower pressures. However, the data indicate that the maximum depression occurred at a pressure of 20 psi (0.010 in. at valve #3). A depression of 0.009 in. was noted at the 2 psi line (valve #3).

Figure 4 Severely Worn Float Valve (#3, 10 psi)

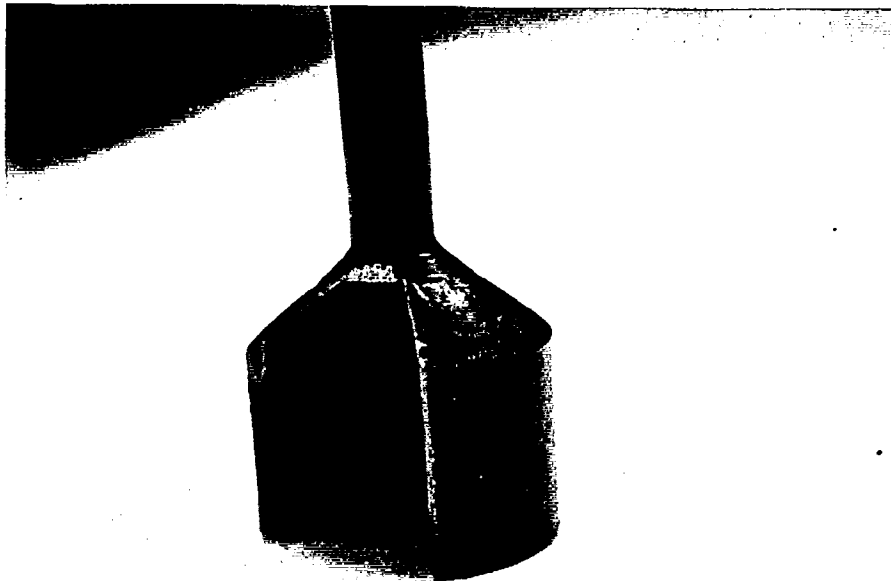
Figure 5 Cut-away of a Worn Float Valve (#3, 20 psi)

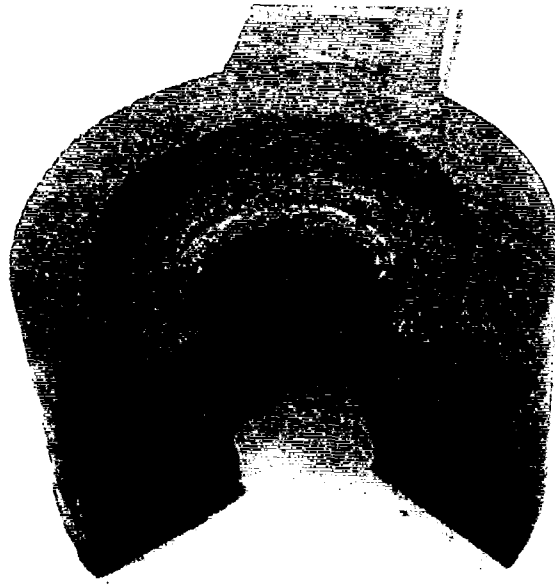
Figure 8 Deformed Valve Seat (#3, 80 psi)
