COMMUNITY WATER SUPPLY AND SANITATION PROGRAMME

STATUS SURVEY
OF
200 WATER SUPPLY PROJECTS

FINAL REPORT

DECEMBER 1989

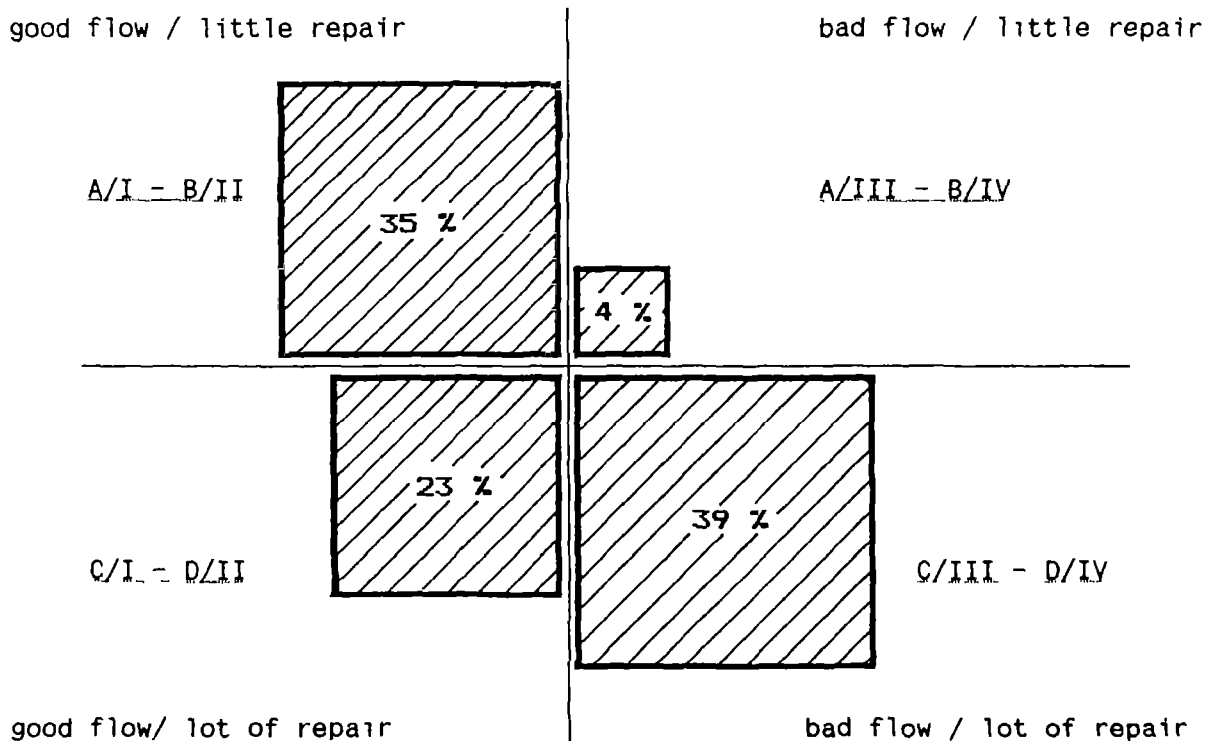
To show the distribution of the projects better, in figure 1 the percentage of each category is shown as an equivalent area.

Above the axis the two good categories are shown and below the axis the two bad ones.

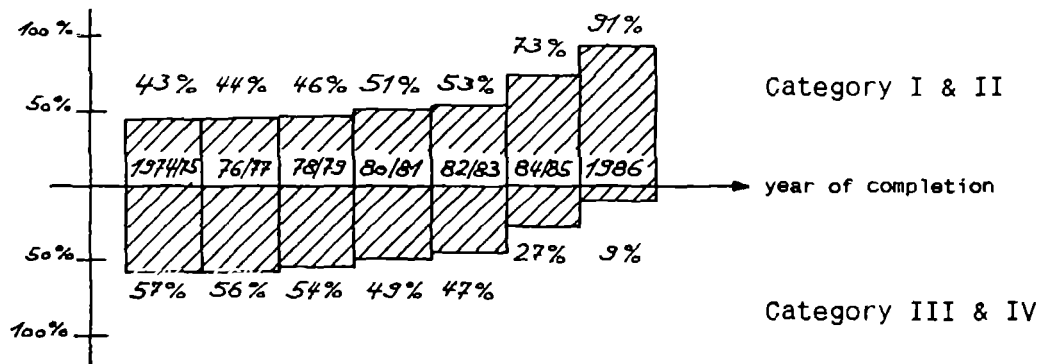
figure 2

Utility (Flow from tapstand):

Figure 2 and 3 show that the utility of the projects is not decreasing at the same speed as is the physical condition of the projects. It indicates that the users will keep the water running as good as they can even if major parts of the project fall into disrepair.

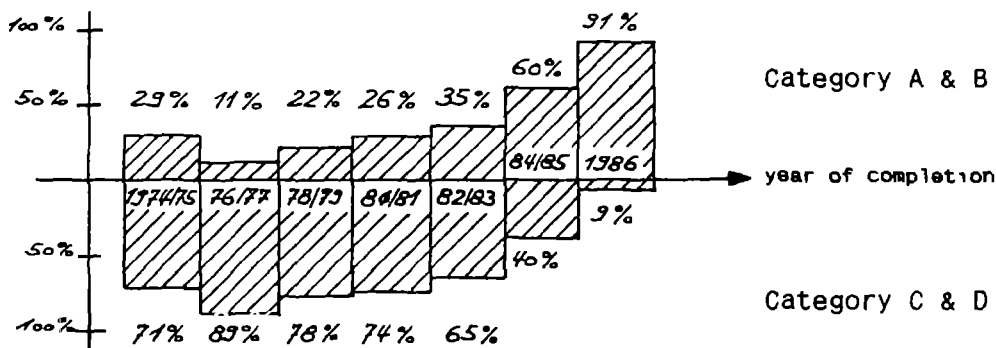
figure 3

Physical Condition (Repair Requirements)

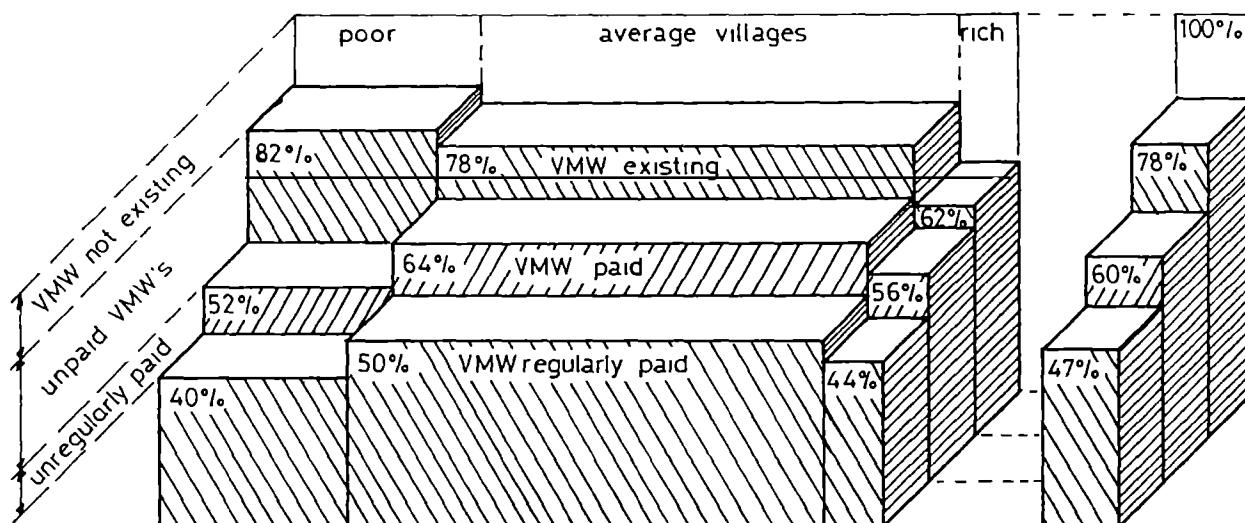
figure 4

In the graph below the economic situation of the village was put into relation to the arrangements for the Village Maintenance Worker.

It shows that poor villages much more often have a VMW than rich villages (82% against 62%). With regard to payment they are situated about the same (40 % against 44%). There is not much of variation with regard to payment of the VMW's. Most probably in poor villages the system of voluntary labour still works whereas in rich villages the VMW's will work only if they are also paid properly.
