Provisional Military Government of Socialist Ethiopia

# Remote Sensing for Water Resources Development

A Demonstration and Training Study

1984

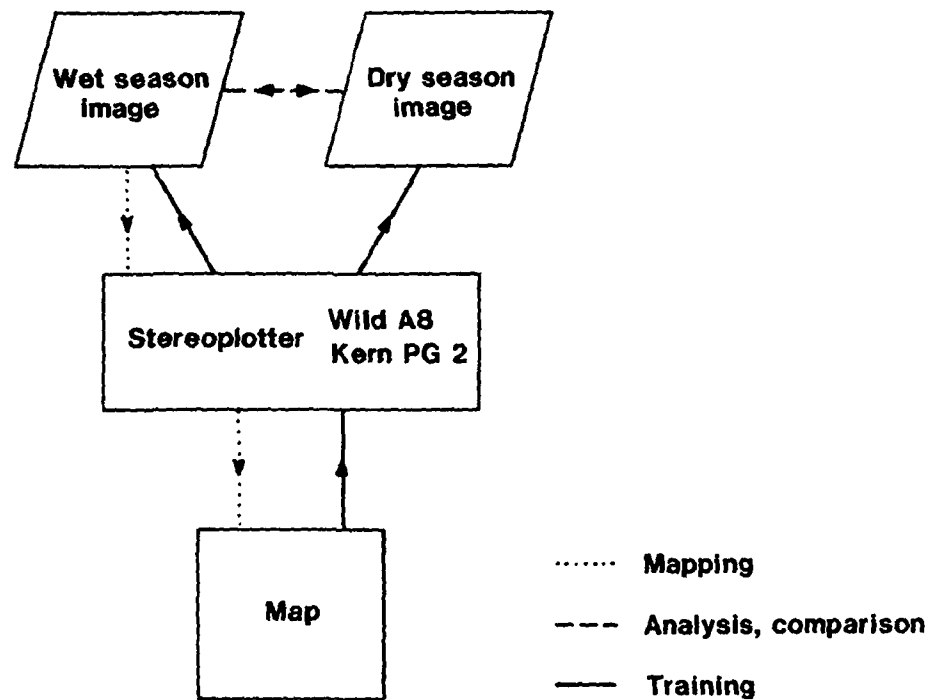
Figure 4 The bitemporal LANDSAT interpretation system used.

It is our opinion that this transfer is best and most accurately done in an analogue stereoplottting instrument of the same type as used for conventional mapping. For this LANDSAT inventory, we have used WILD A8 and B8 stereoplotters. In connection with the field-check during the actual project, we had the opportunity of using the Kern PG2-plotter at the Ethiopian Mapping Agency in Addis Ababa. The arrangement for this bitemporal stereoscopic LANDSAT analysis is shown in Figure 4.

The different steps in the orientation of the images, scaling and mapping are described in Appendix 3.

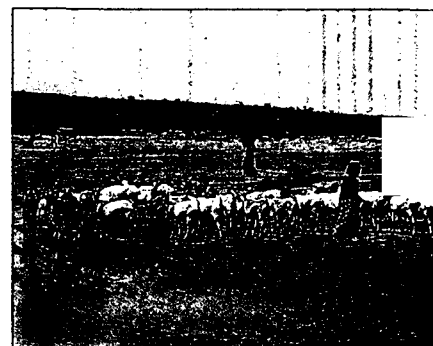
3 Outflow of groundwater in a sand river.

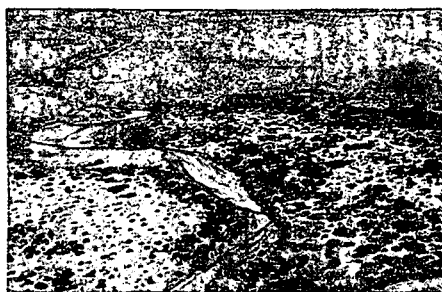
**3** Spring-fed stream with light tones, indicating salt deposits.

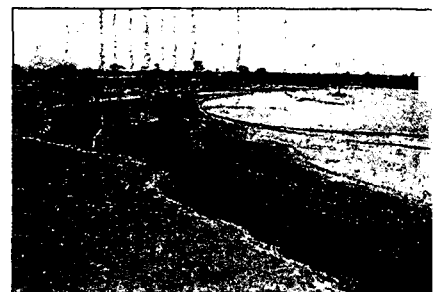
**4** Perennial stream with intensive bank erosion in alluvial deposits.
