Rehabilitation of Hand-Dug Wells and Protected Springs in Kisii, Kenya

REHABILITATION OF HAND-DUG WELLS AND
PROTECTED SPRINGS IN KISII, KENYA

Thesis submitted to the department of
civil engineering, Tampere University
of Technology in partial fulfilment
of the requirements for the degree of
Master of Science in Engineering

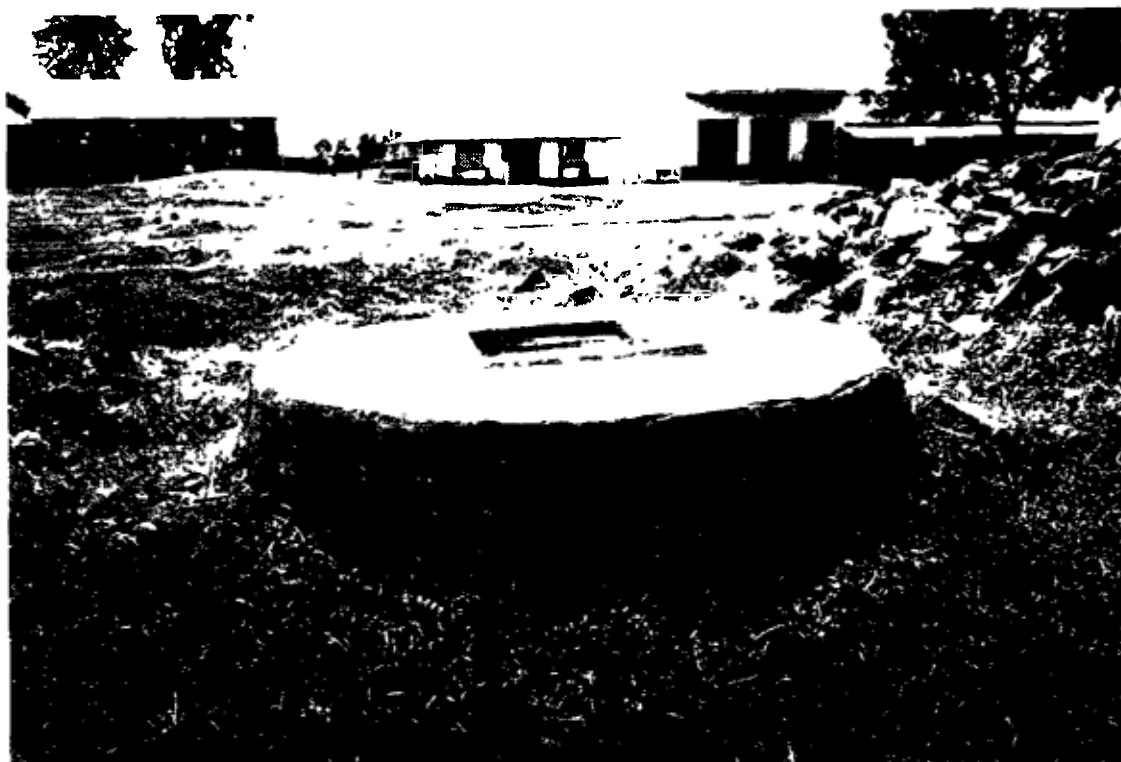
Figure 14. Hand-dug well No. 20.

Figures 14, 15 and 16 show the existing hand-dug well conditions. It is evident enough that most if not all the wells are contaminated. The bacteriological water analyses from the 59 wells tested showed that 34 % of the wells had between 11 and 100 faecal coliforms per 100 ml of sample. The remaining wells (66 %) had more than 100 faecal coliforms in 100 ml of water sample. Of the 110 wells visited in the study area, 57 wells had no covers, 91 wells had no superstructure or lining. All the 110 wells had no sanitary arrangements for drawing water. The rehabilitation of these hand-dug wells is necessary in order to provide water of good quality to the users and a reliable supply in all seasons.
