Handpumps: Toward a Sustainable Technology Research and Development During the Water Supply and Sanitation Decade

by John Reynolds

Water and
Sanitation
Report

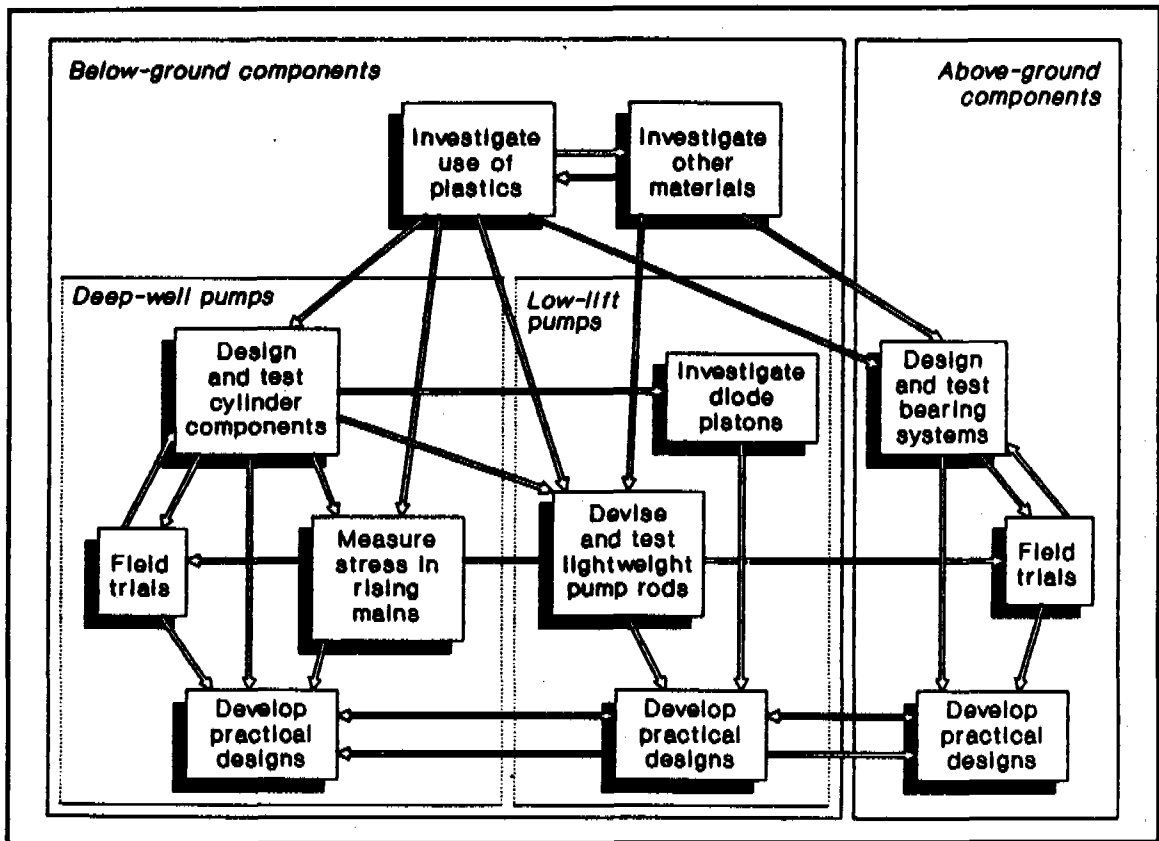
Figure A3: The handpump research program

In practice, these strands of research were closely interrelated, as Figure A3 illustrates.

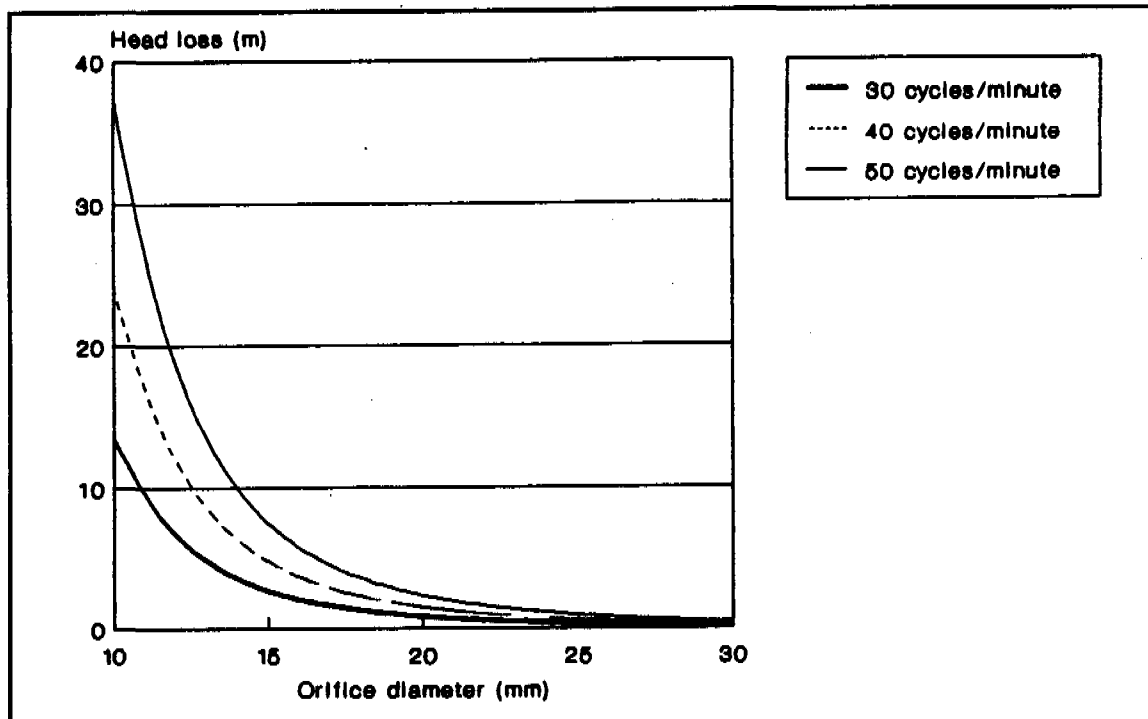
Figure B1. Head loss versus valve orifice diameter

The footvalve snap-in feature was redesigned to eliminate excessive stress, and the barbs intended to limit valve lift were removed: many had broken during the tests. The valve orifice diameter was increased to 20 mm. This size was chosen as a compromise between ensuring that water would still flow through the valves relatively quickly, to flush suspended solids in the water and prevent valve seat contamination, while reducing resistance to flow to a level that would not significantly increase the applied force at the handle. Figure B1 illustrates the relationship between head loss and valve diameter for a range of pump operating speeds, based on the dimensions of the experimental cylinder and the stroke of the Maldev pump.
