AN ASSESSMENT OF RAINWATER CATCHMENT SYSTEMS IN BOTSWANA

John E. Gould

A THESIS

Spring 1985

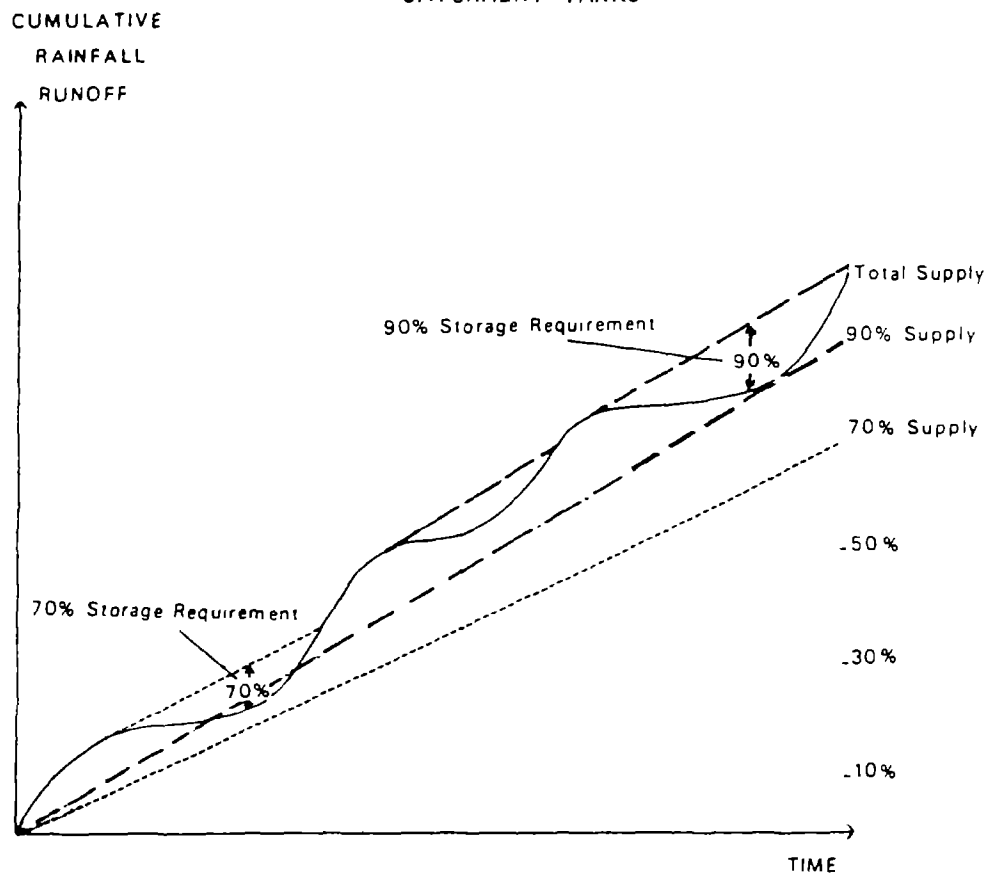
THE APPLICATION OF MASS CURVE ANALYSIS
FOR STORAGE DETERMINATIONS OF RAINWATER
CATCHMENT TANKS

Figure 5.3 ...Mass Curve Analysis : Storage Determination

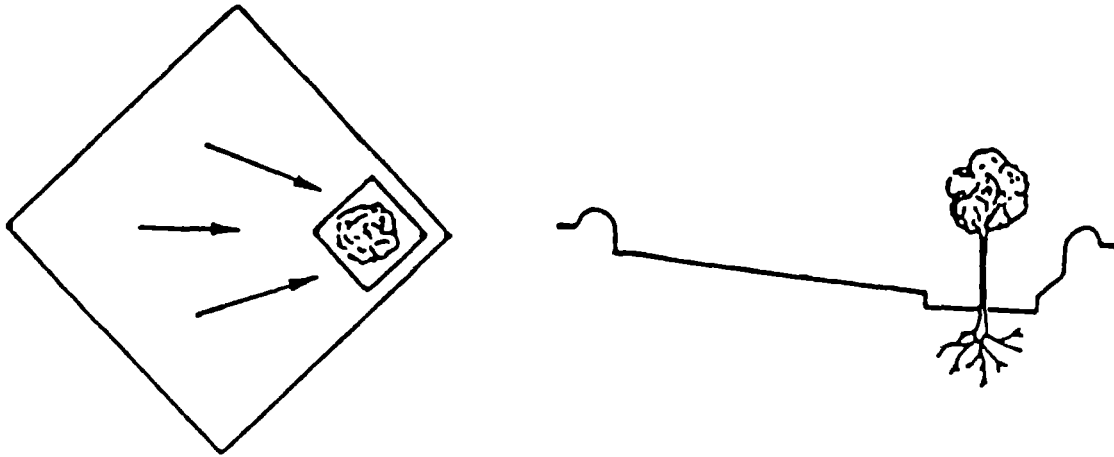
Figure 7.1 ...Plan and Cross-Section of a microcatchment(Adapted from N.A.S. 1974)
