ENDURANCE TESTS OF ROBOVALVES

WASH FIELD REPORT NO. 102

SEPTEMBER 1983

Yaron M. Sternberg
and
Robert Knight

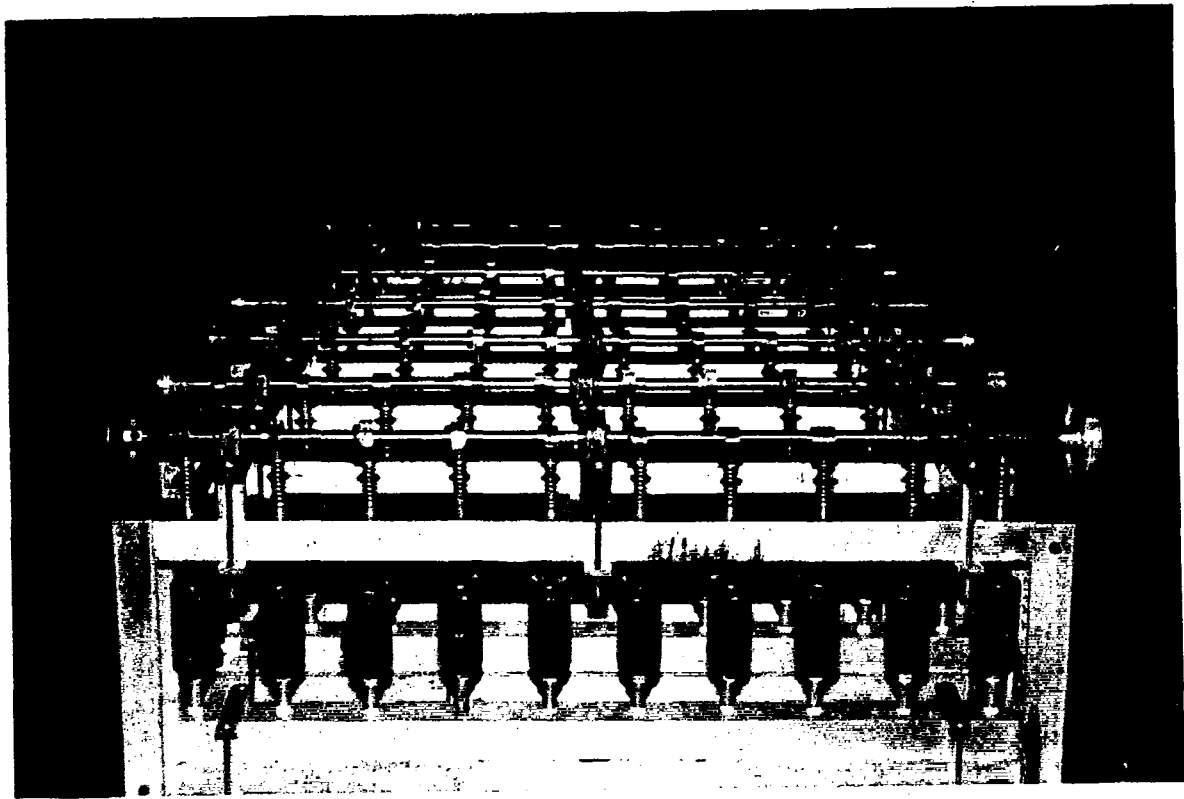
Figure 1 Endurance Test Rig

The test rig shown in Figure 1 (Appendix C)* consisted of an aluminum frame structure which housed seven banks of ten robovalves, a one-cubic-meter reservoir, and a two-stage, 3 H.P. centrifugal pump. Each bank of ten valves was supplied with water through a common distribution header and individually controlled by its own water pressure regulator. Each bank also had a water pressure gauge as shown in Figure 2.

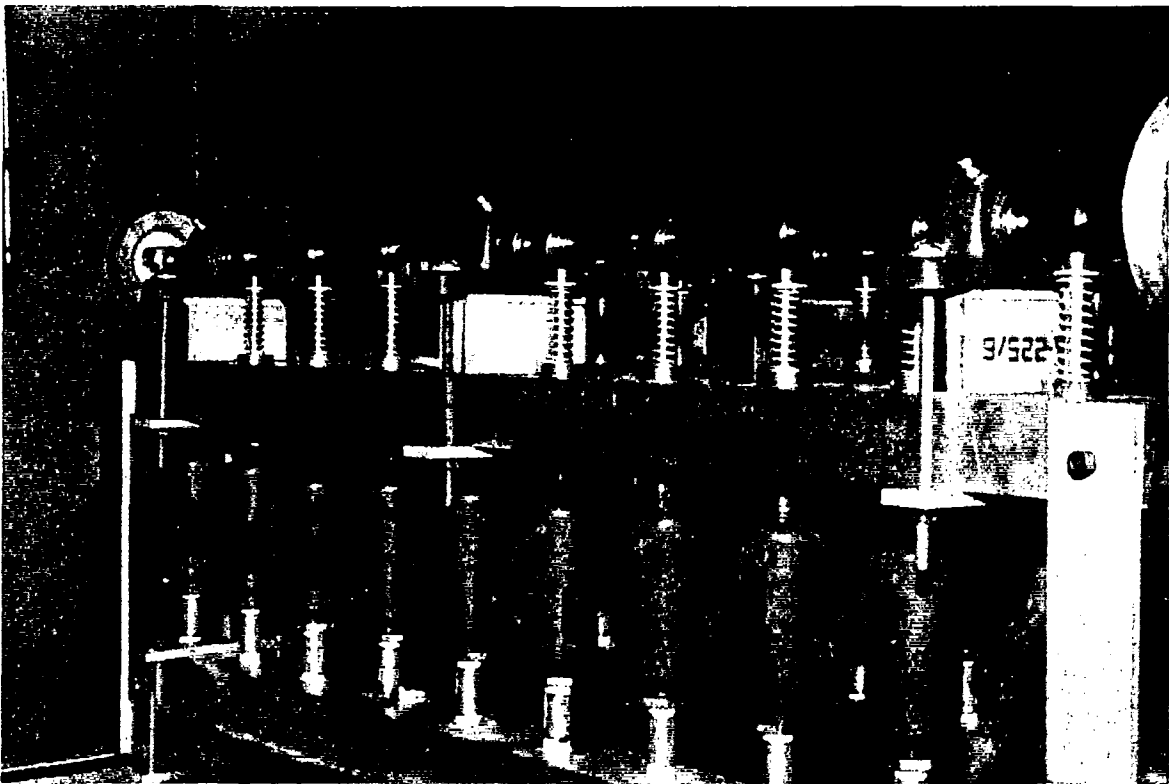
Figure 3 Camshafts and Pushrods Arrangement

The opening and closing of the valves for the tests were achieved through an arrangement of cams and pushrods, as shown in Figure 3. The camshafts were driven by two electric motors (1/3 H.P.) and a series of V-belts and pulleys. The recirculating water supply was provided by the two-stage pump.
