POINT-OF-USE REDUCTION OF VOLATILE HALOGENATED ORGANICS

IN DRINKING WATER

Gordon Bellen, Marc Anderson, Randy Gottler National Sanitation Foundation PO Box 1468 Ann Arbor, MI 48106

Contract No. R809248010

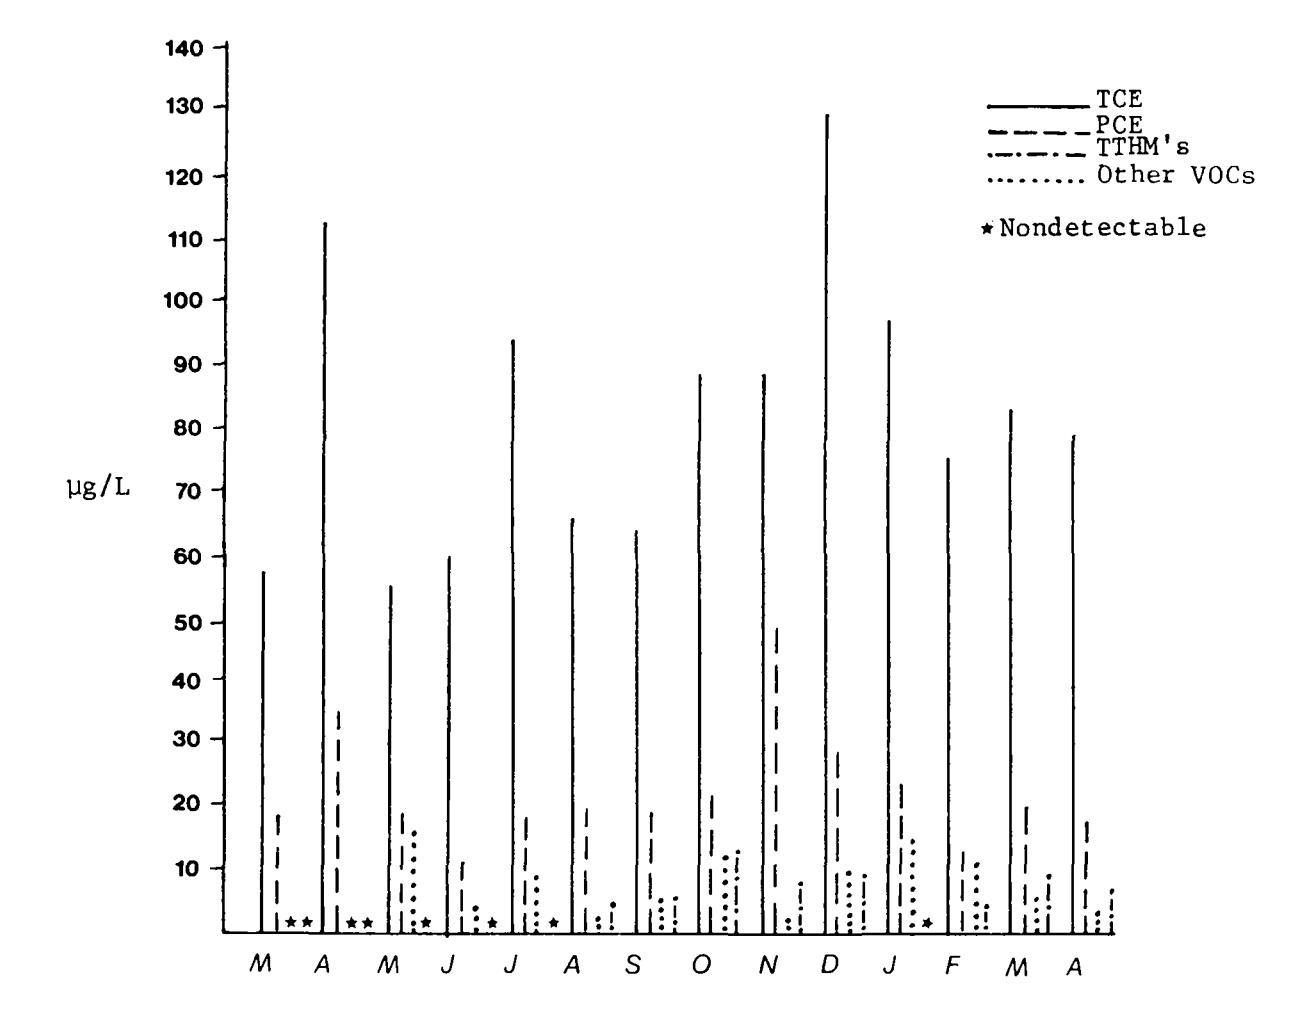
Figure 1. Mean VOC concentrations in influent samples collected by month.

Figure 1 shows the mean influent VOC concentrations in distribution system (predevice) samples. The results are presented by month for TCE, PCE, TTHMs, and the other VOCs found (1,1,1-trichloroethane and carbon tetrachloride). The concentrations of VOCs found varied from sample to sample. For example, the range of results for TCE was 133 μ g/L with a relative standard deviation of \pm 31 percent. Predevice samples were collected at different locations in the distribution system during the study, but there was no apparent pattern in VOC concentrations which could be attributed to sampling location. There also does not appear to be a seasonal pattern to VOC concentrations.

The influent VOC concentrations closely paralleled the concentrations found in Well No. 4. Well No. 4 was used as the primary water source for Silverdale.

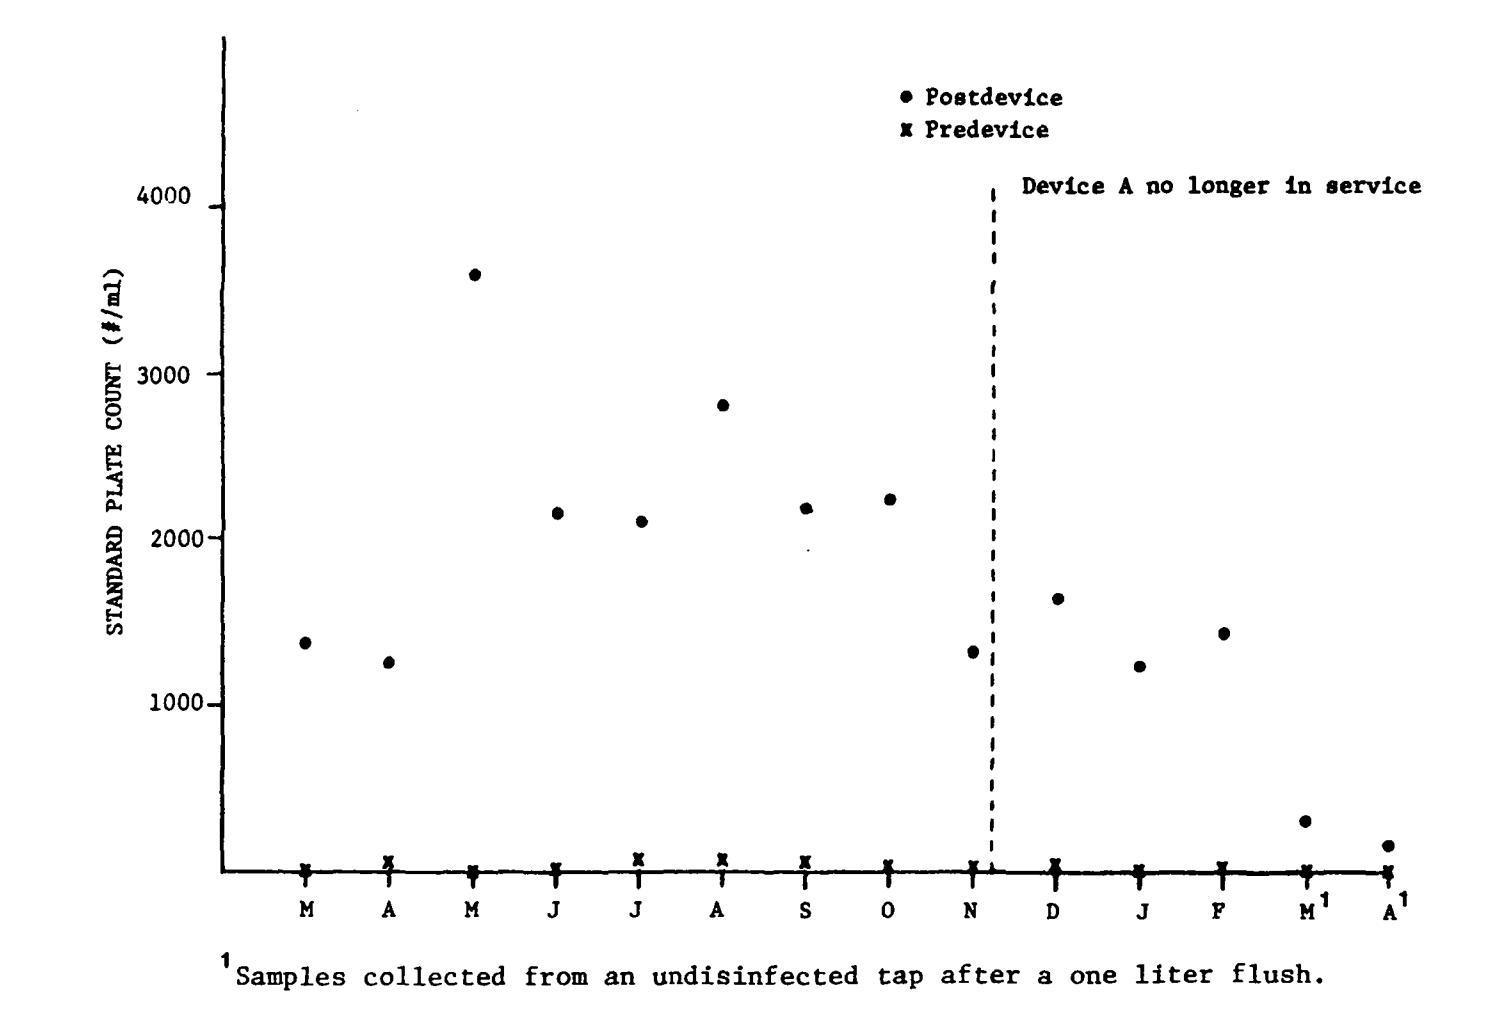
Figure 2. Geometric means of Silverdale pre and postdevice standard plate counts by month.

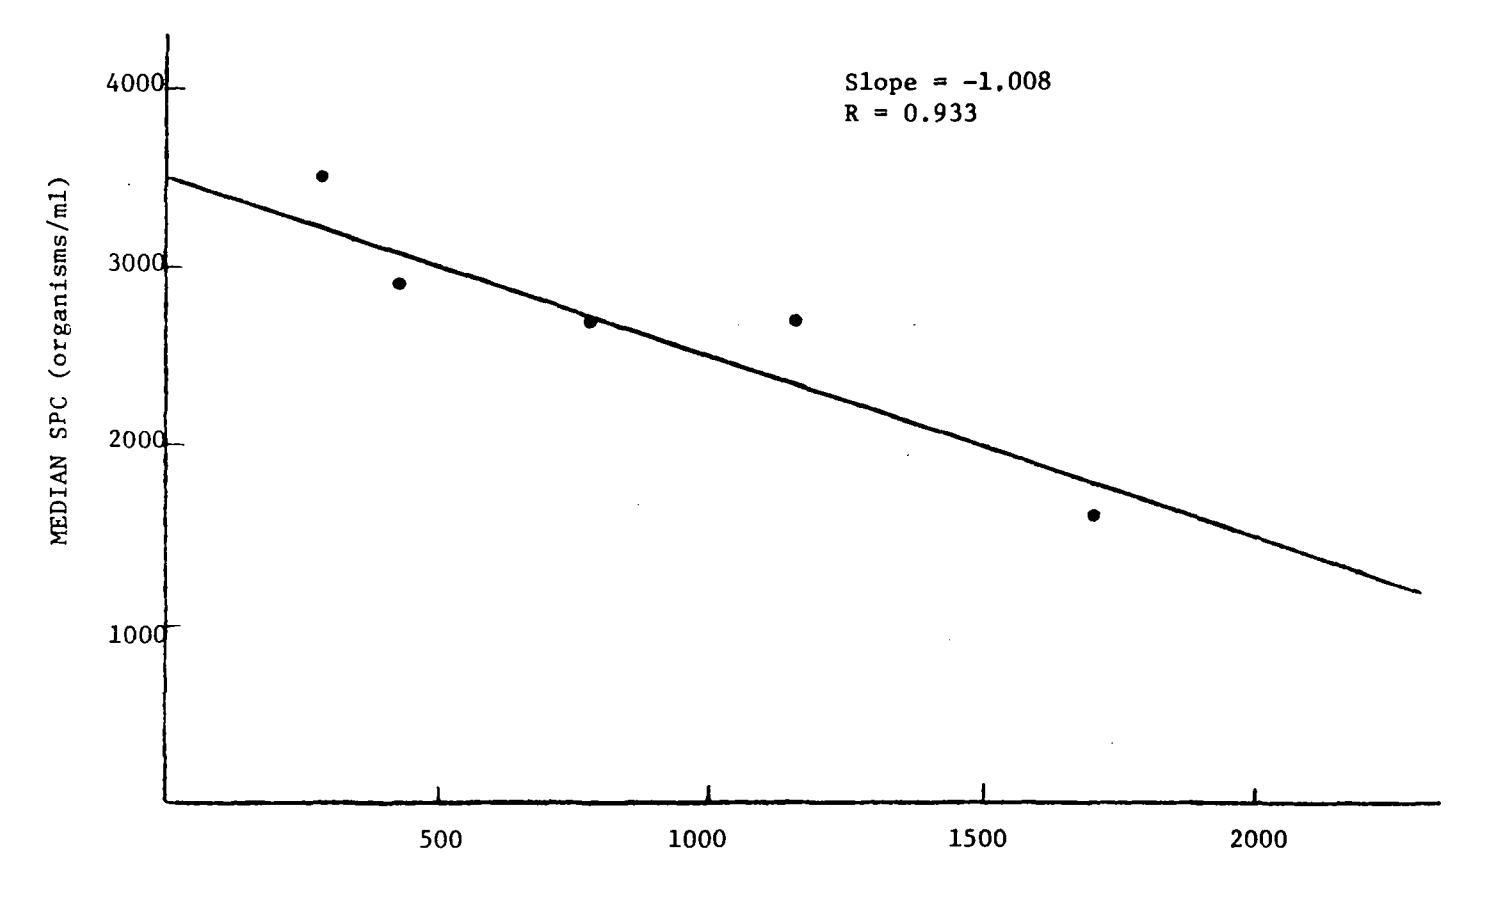
Figure 3. Median postdevice SPC densities versus grams of carbon.

Table 16 shows median SPC densities for each model, as well as grams of carbon and whether or not the carbon is silver impregnated. Under the conditions encountered in this study, silver impregnation does not appear to affect microbial density. Combined mean and median SPC densities for silver and non-silver impregnated carbon are presented in Table 17. There is not a significant difference in the microbial densities; however, the SPC densities in postdevice samples from silver impregnated carbon devices are higher.

The correlation of median SPC densities with grams of carbon is an empirical observation. All five models have different design features which could affect the postdevice SPC densities. Although efforts were made to control sampling by collecting the first flow of water through a device on its sampling day, it could not always be verified. To adequately study any correlation between SPC densities and carbon quantity would require an experiment designed for the purpose. If, in fact, postdevice bacterial densities could be reduced by using more carbon, then that could be a good design parameter for point-of-use treatment devices. However, further study is needed.

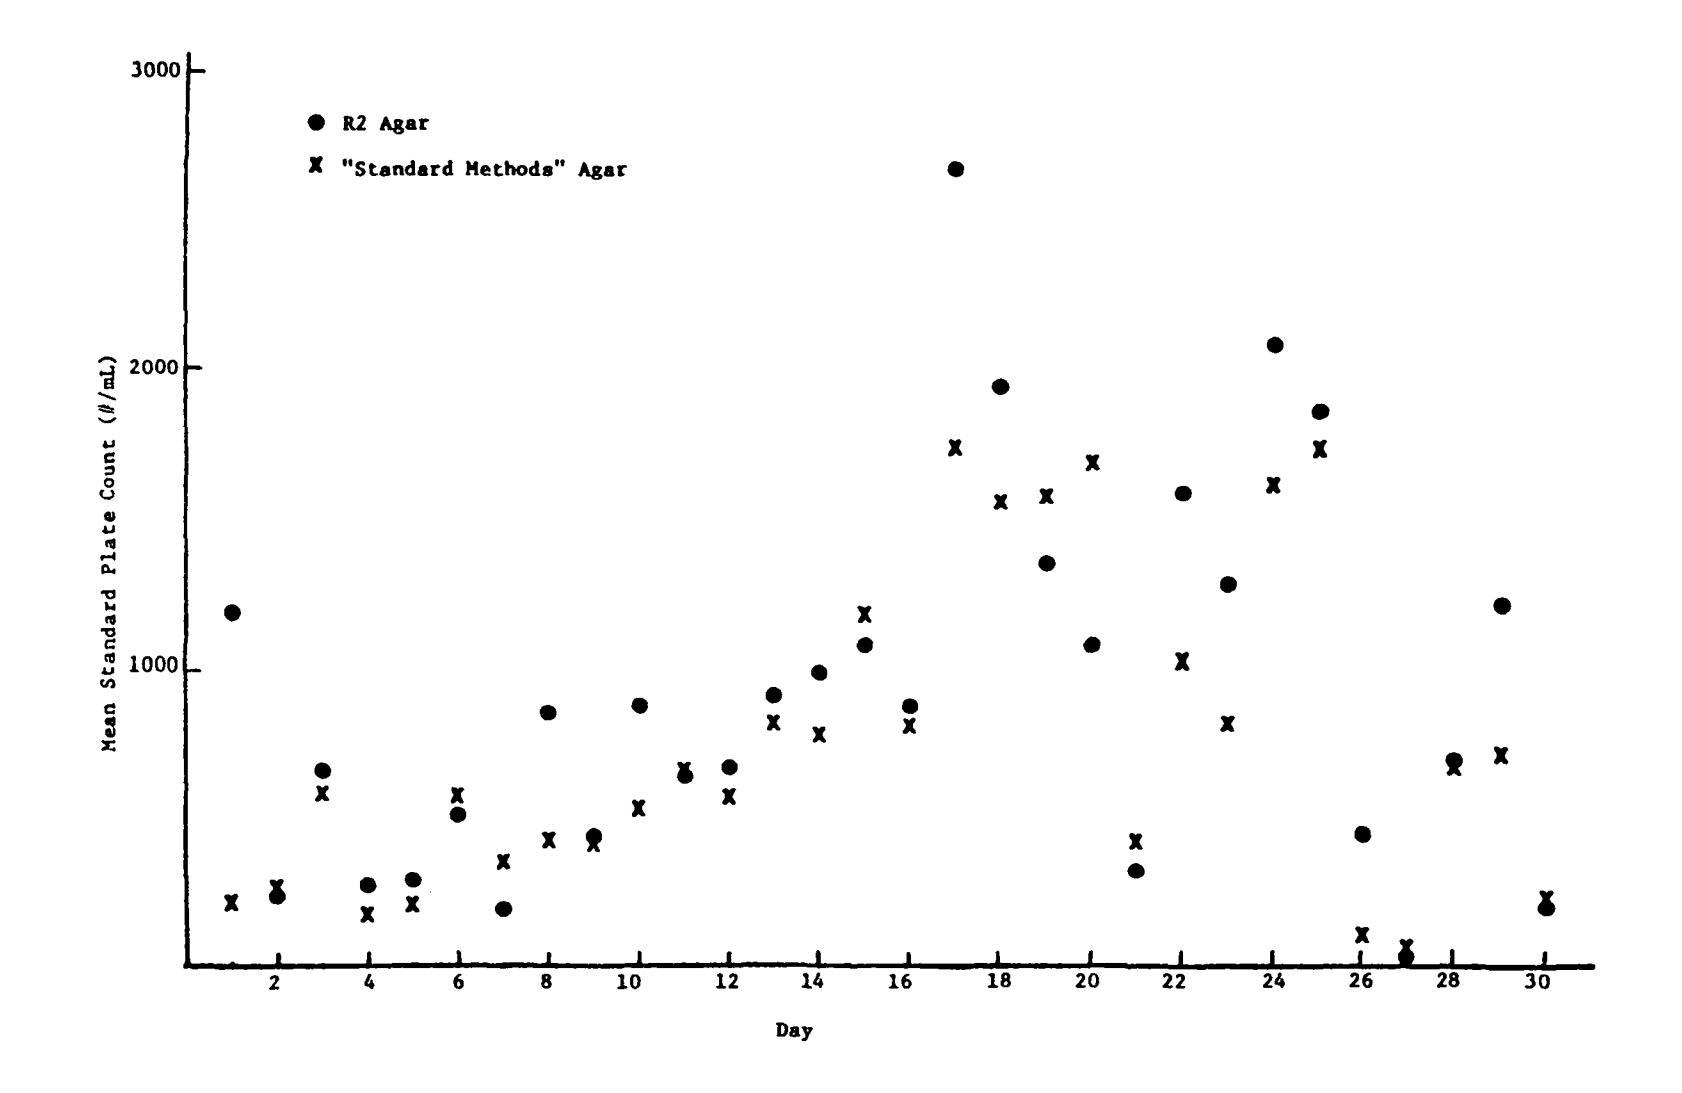
Figure 4. Comparison of standard plate count agar, unflushed postdevice samples, March-April, 1984.

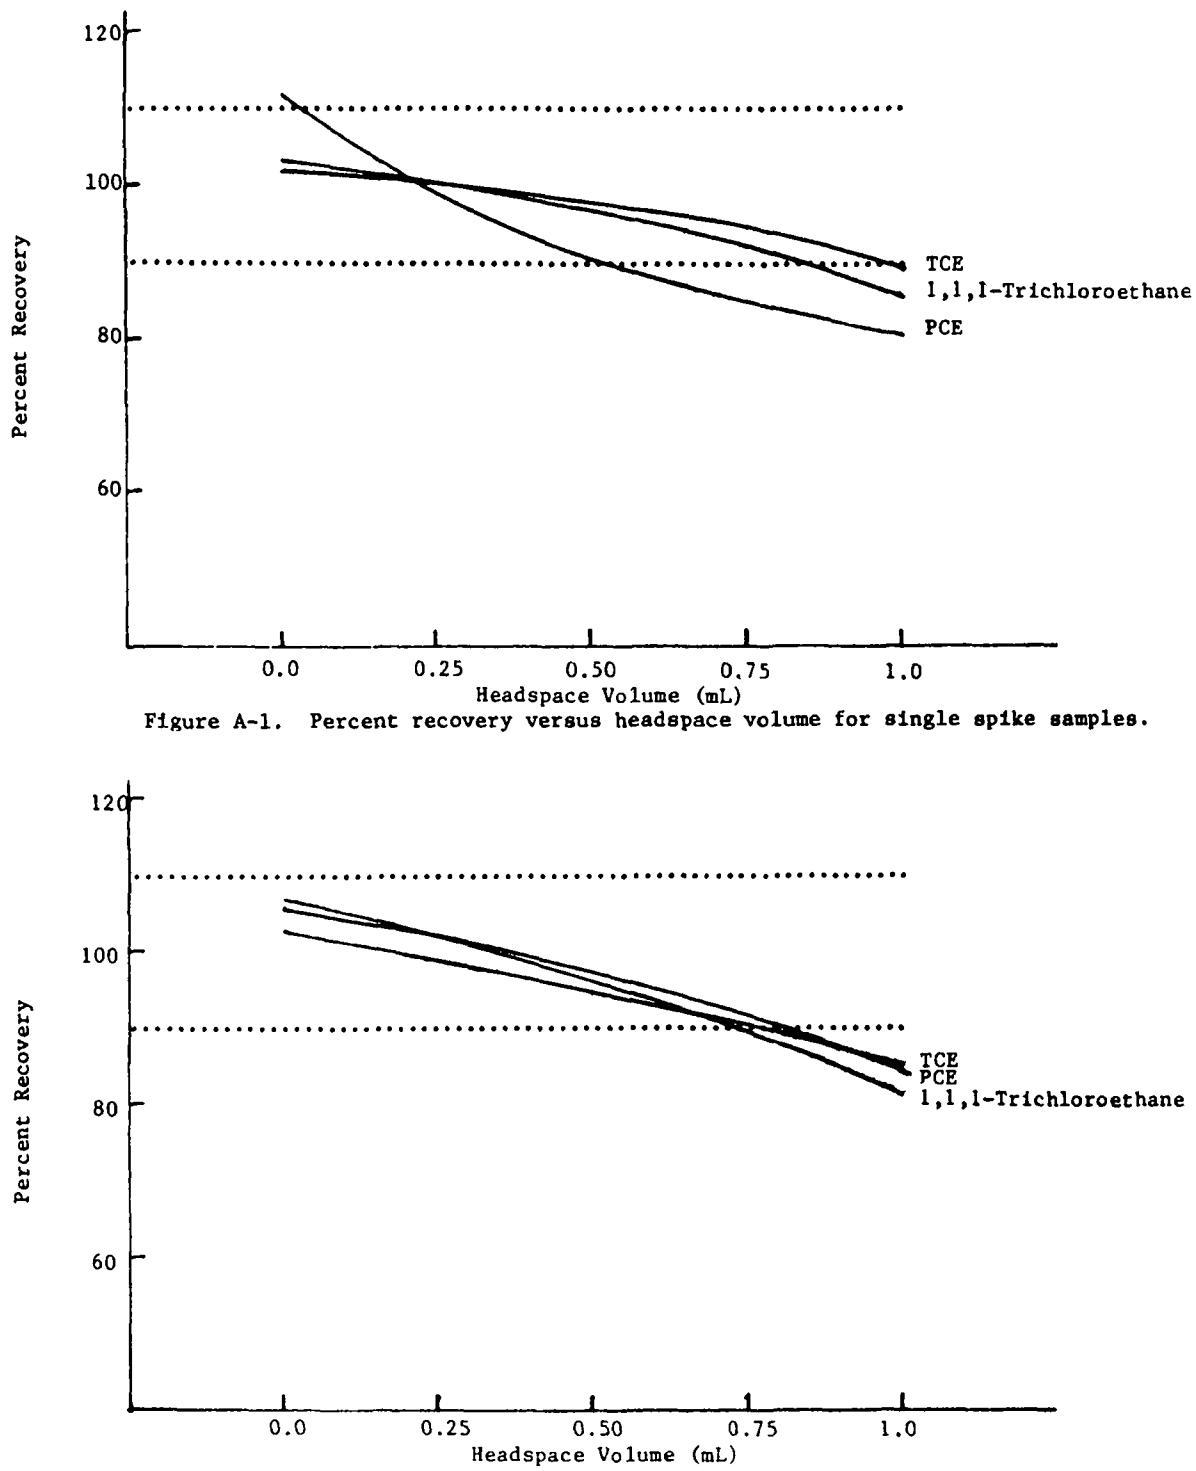
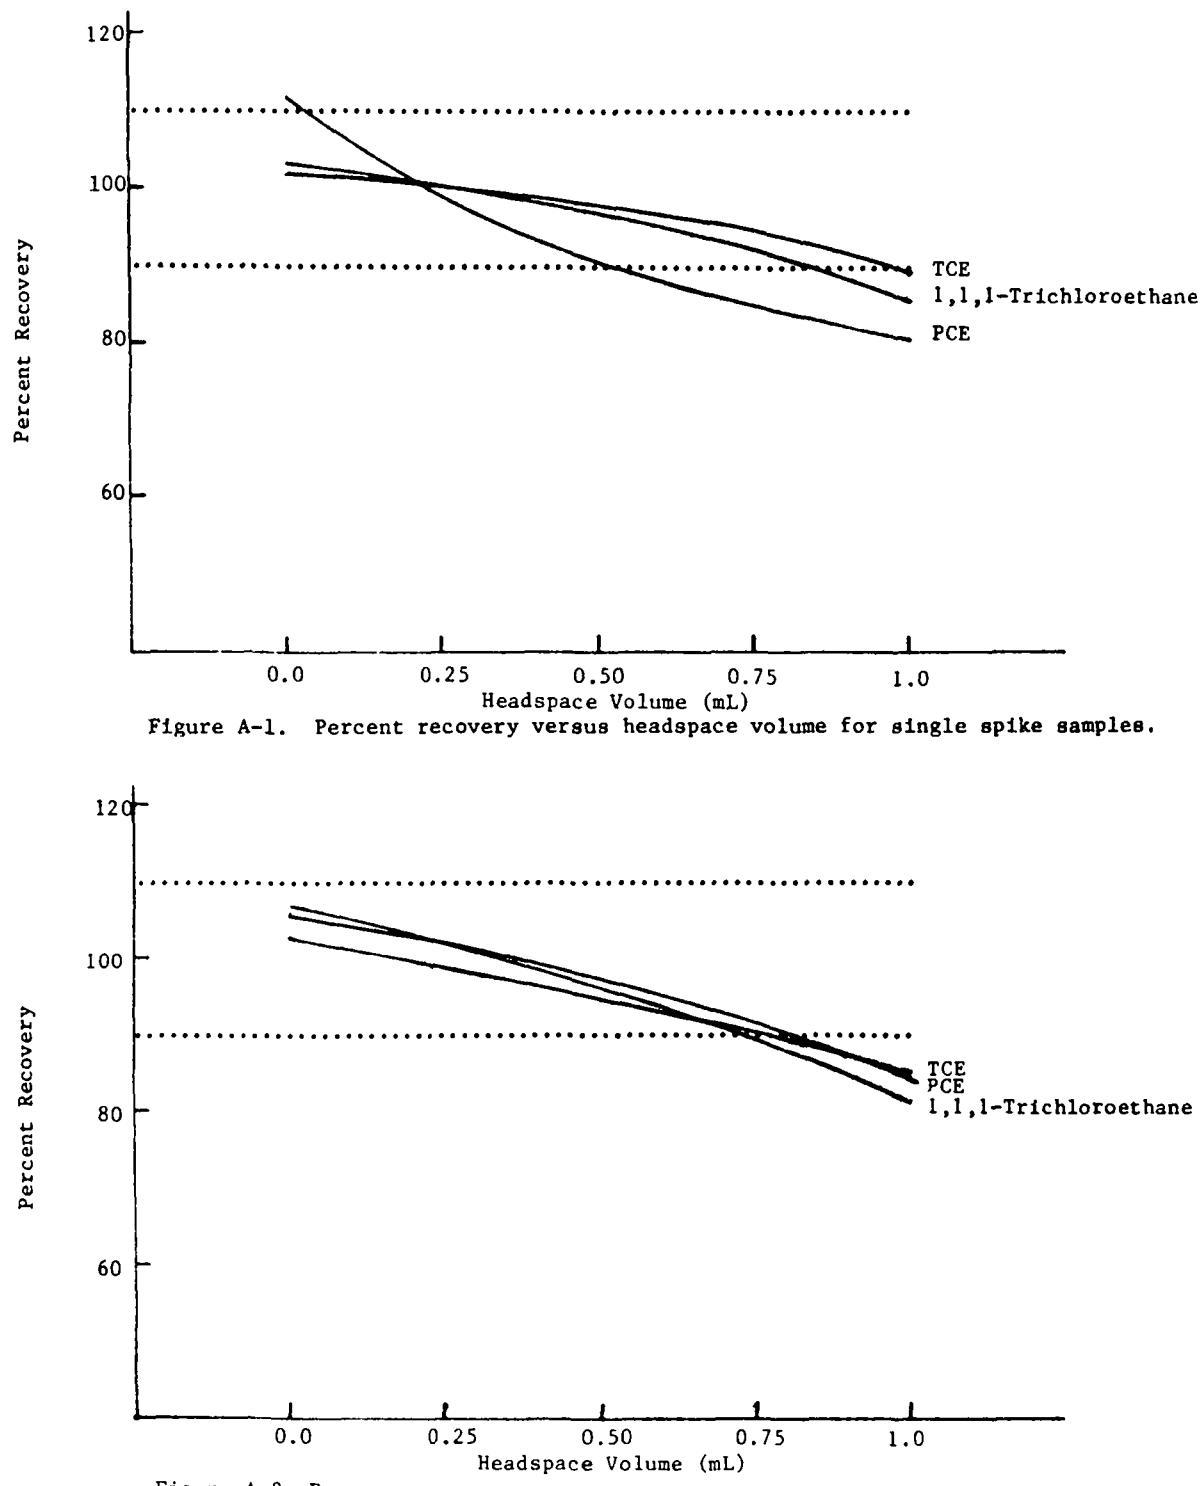
Figure A-2. Percent recovery versus headspace volume for multiple spike samples.

Mean percent recoveries were calculated based on the original sample concentrations listed in Table A-1. Figure A-1 shows mean percent recoveries versus headspace volume for each chemical from vials spiked with one chemical. Figure A-2 shows percent recovery versus headspace for vials containing all three chemicals (multiple spike). Figures A-3 and A-4 show single and multiple spike recoveries versus holding time. The dotted lines indicate 100 + 10 percent recovery.

It is apparent that as headspace volume increases, there was some decrease in percent recovery. With the exception of the single spike for PCE, recoveries remained within the \pm 10 percent range for headspaces of up to 0.75 mL. In all cases, percent recovery remained within a range of 100 \pm 10 percent for up to 0.5 mLs of headspace.

Figure A-1 and A-2 indicate that the headspace effect may be more pronounced for the multiple spike. The multiple spike best reflects the composition of raw water samples for this study. Consequently, it was determined that the headspace effect was only significant in raw water samples with headspace volumes greater than 0.5 mLs. Data from raw water samples with greater than 0.5 mLs headspace were not used in this report.

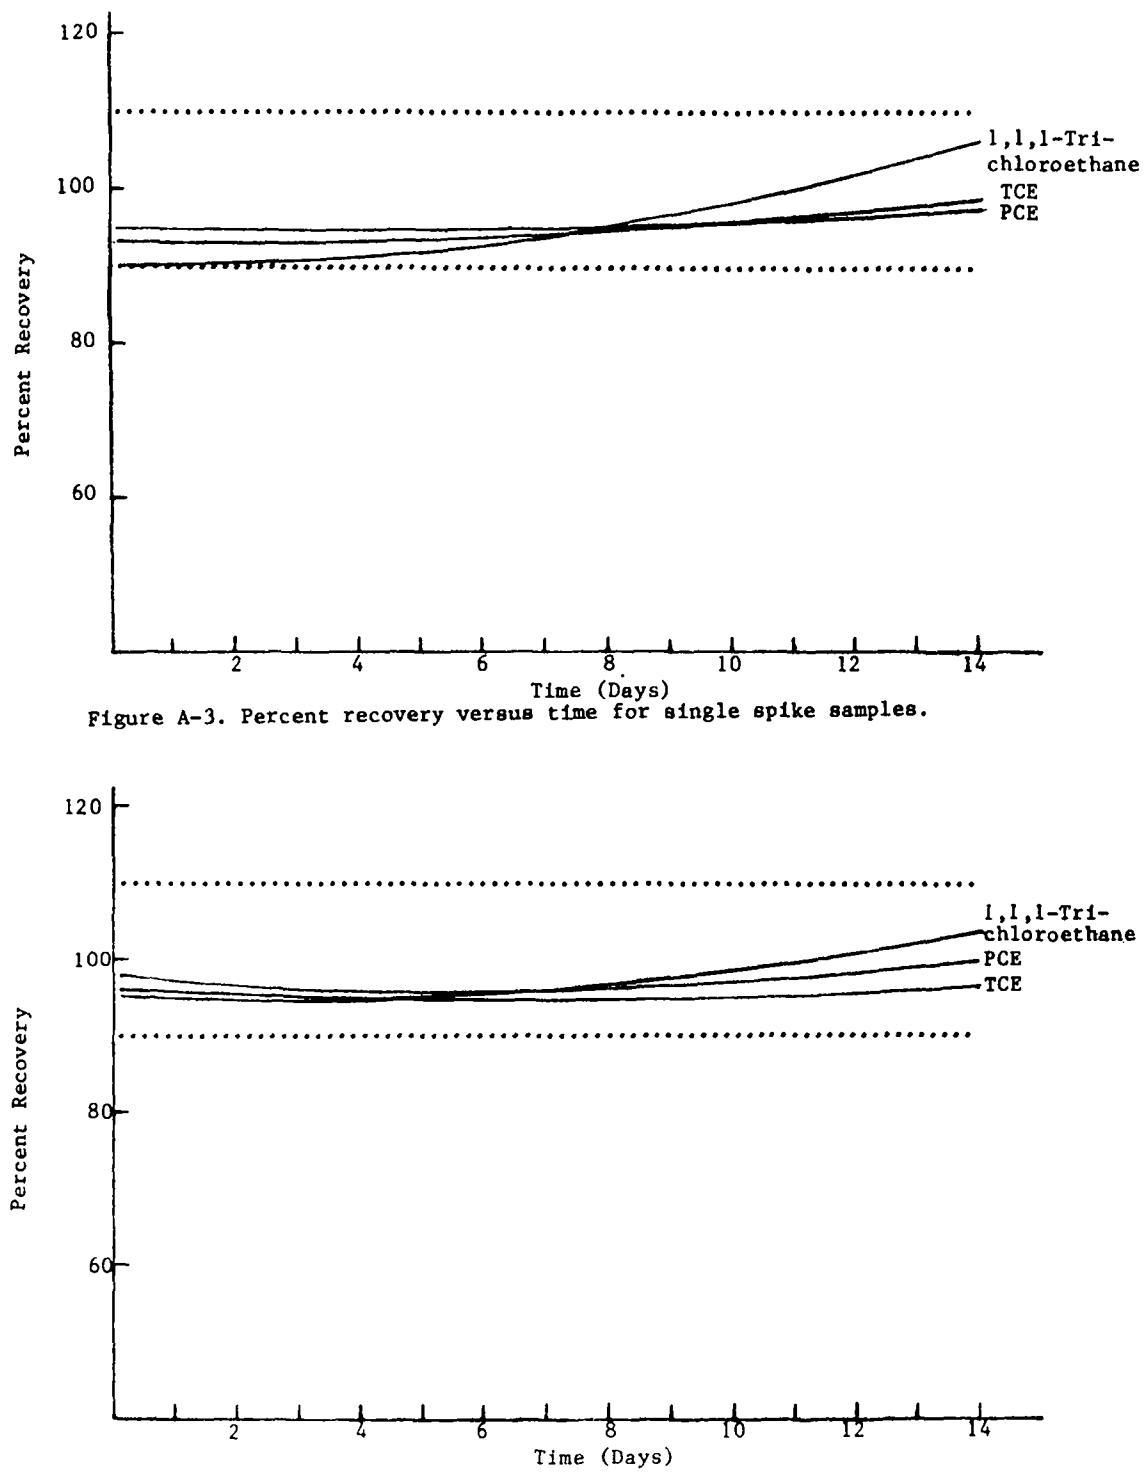
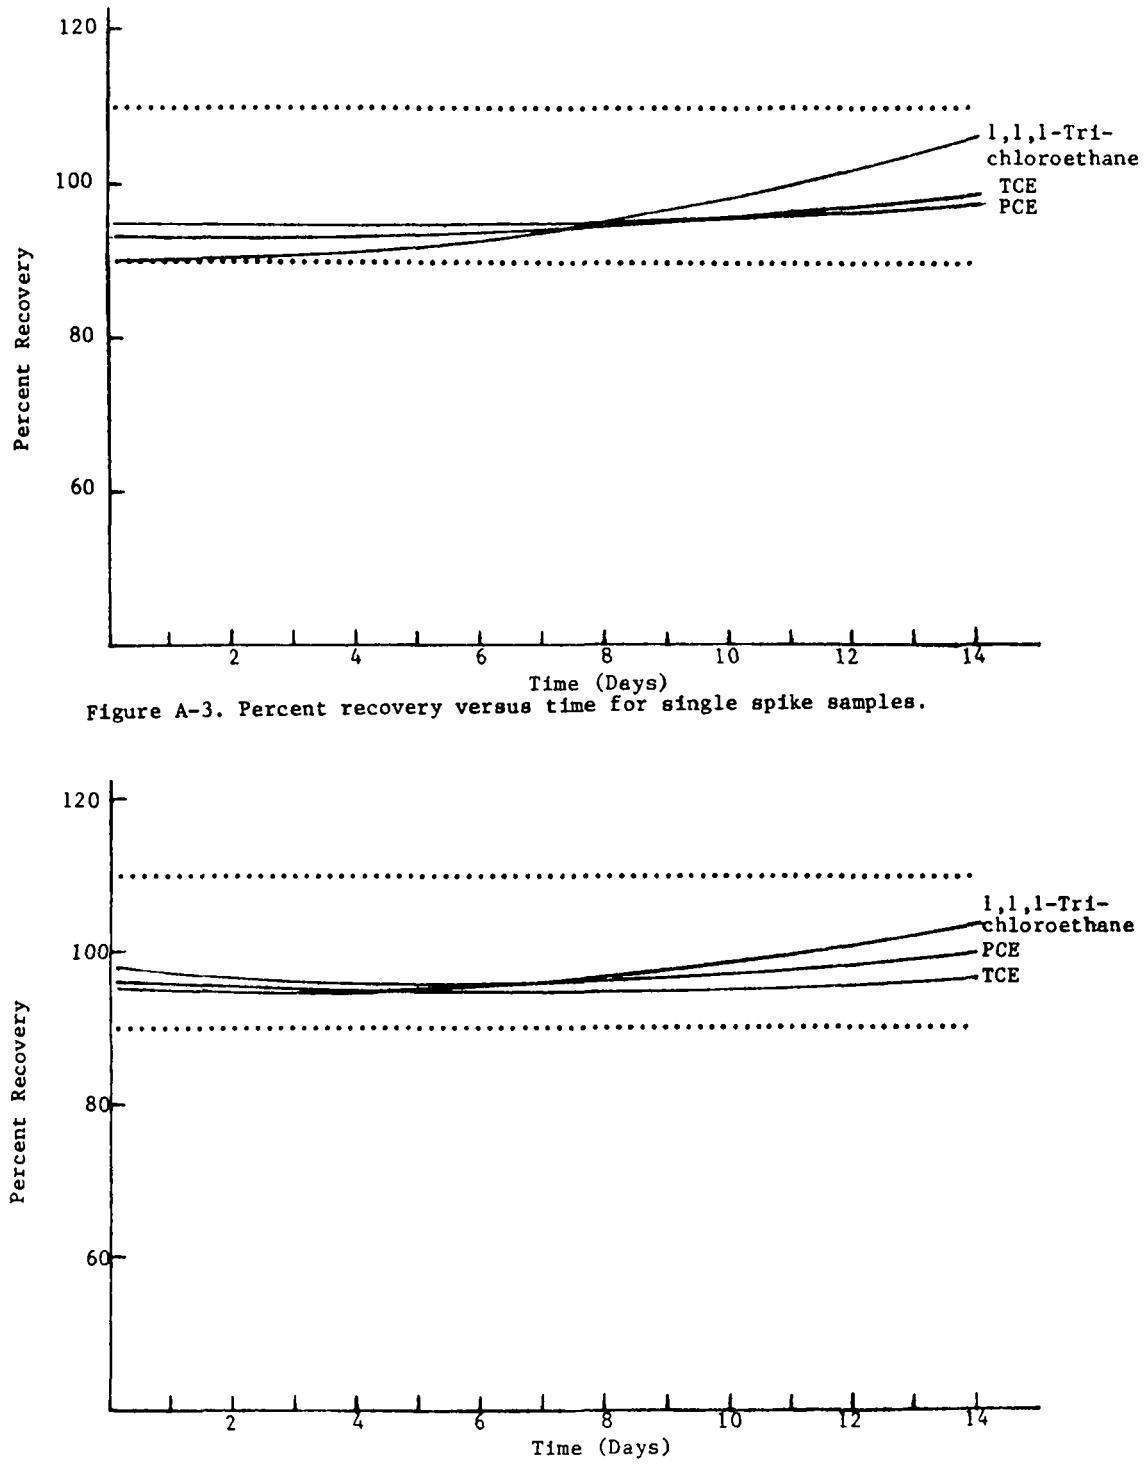
Figure A-4. Percent recovery versus time for multiple spike samples.

Three of the five remaining tables show a significant headspace effect, but none show a holding time effect. There is not apparent headspace/holding time interaction. The fact that there is no trend of significant headspace/time interaction means that the effect of headspace on recovery is independent of holding time.
