# Saline wells in Aceh

**The drinking wells in the areas of Aceh affected by the tsunami were polluted with debris and salt water. How has their rehabilitation progressed in the months since?**

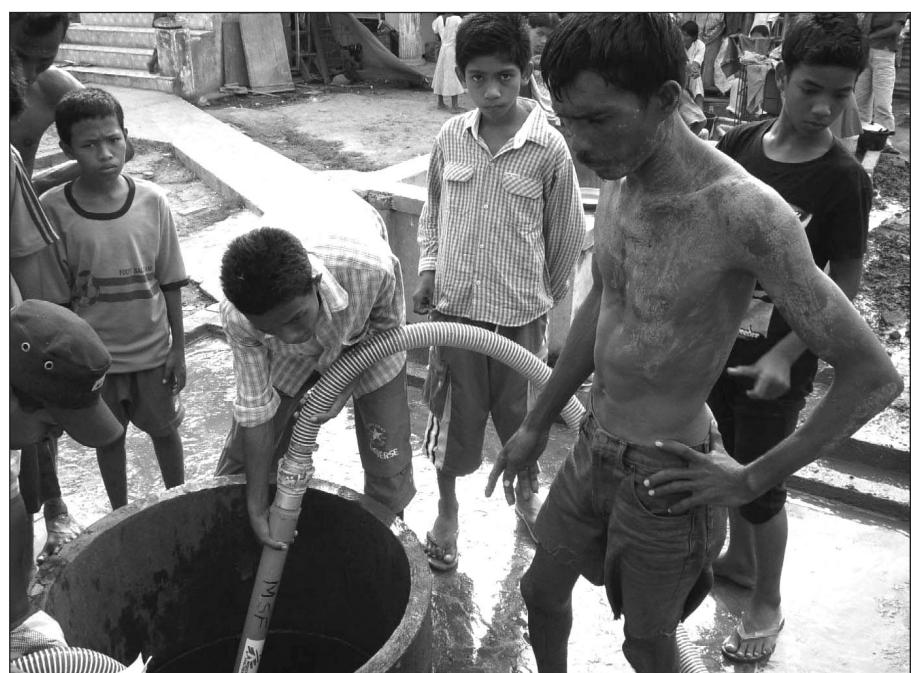
The team cleans a well using a surface pump

A well-cleaning team of three people was trained and equipped, with specially developed well-cleaning tools. The team started by cleaning an average of five wells per day. When the well cleaning first started (February 2005), in the absence of proper equipment, the turbidity was assessed from samples collected in transparent bottles, before and after the cleaning. Taste tests were conducted over several days, and interviews with users yielded qualitative information on improvements in the salinity of the well water. This primitive but effective monitoring was replaced in March by a more objective approach using conductivity and turbidity meters.

- Pumping out turbid water, scrubbing the walls, and cleaning the floor up to the sandy soil improved the turbidity of the water to a pre-*tsunami* standard. This resulted in an initial reduction in conductivity by sometimes up to 50 per cent, but this was generally not enough to produce water fit for drinking.
- The pumping rate must be slow to match the well yield and to avoid wells collapsing or shallow aquifers being disturbed.
- Repeating the cleaning procedures gave no further improvement to water quality.
- The intrusion of seawater in the aquifer near shrimp/fish farms

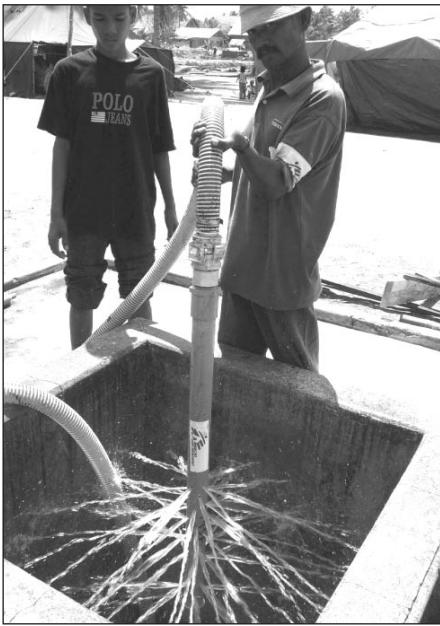
A specially designed tool is used to flush the side walls of a well

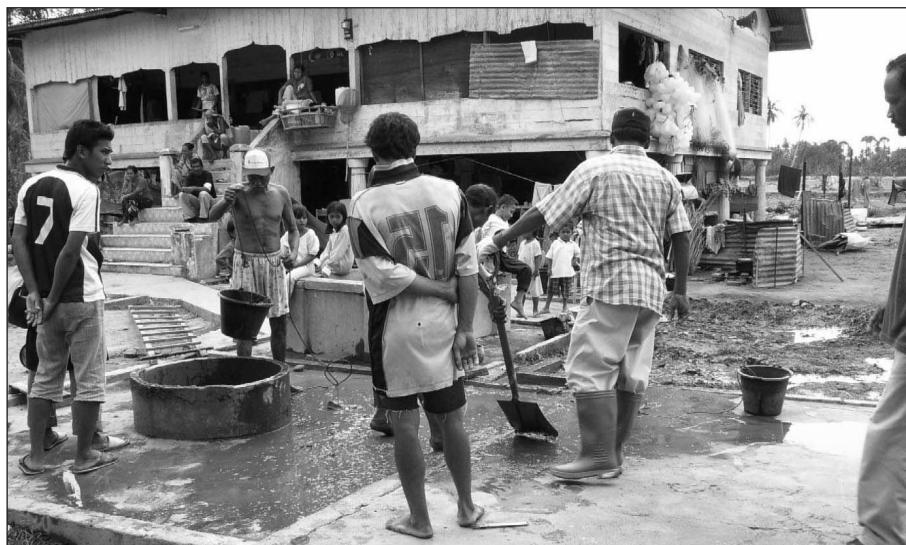
Mud and debris are extracted from a well
