COMMUNITY WATER SUPPLY

THE HANDPUMP OPTION

Rural Water Supply Handpumps Project

Community Water Supply: The Handpump Option

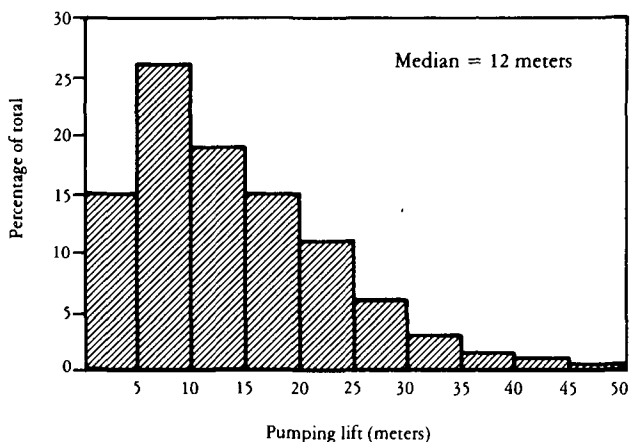
Figure 2.1 Pumping Lift Frequency Distribution in Field Trials

In the Project field trials, efforts were made to site wells where groundwater was as deep as possible — the aim being to develop handpumps suitable for deepwell applications. However, as the diagram shows, 75% of the wells involved pumping lifts of less than 20 meters, and 85% were less than 25 meters. It seems likely that these figures are a good reflection of the global situation in terms of groundwater depth.

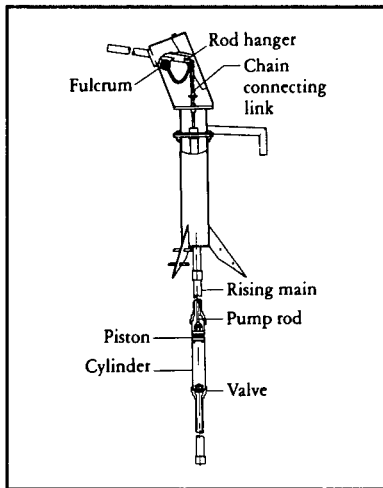
In deepwell pumps, the cylinder is immersed below the water level. They are suitable for lifts down to 45 meters or more, depending on the effort that users

are willing to apply for progressively less water as depth increases. The submerged cylinder eliminates the need for priming, but means that repairs or maintenance involve removal of components from down the well.

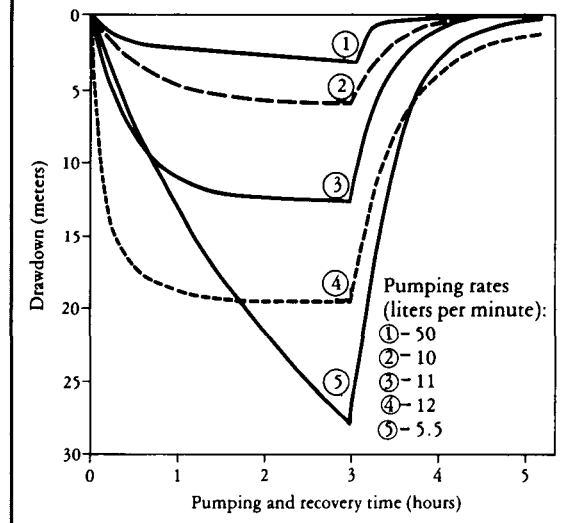
Figure 4.2A Drawdown and Recovery of Five Handpumped Wells in Southern Ghana

such as permeability are often more important than the pumping rate in determining drawdown, as evidenced by Curve 1, where the well with the highest pumping rate has the least drawdown.

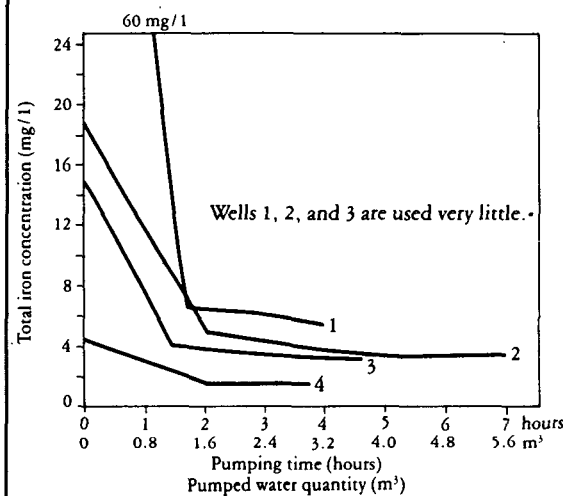
Figure 4.3A Variations in Iron Concentration during Pumping

handpump were being attacked by corrosive groundwater. Natural groundwater iron content measured in wells equipped with corrosion-resistant handpumps in the West African field trial areas has generally been found to be less than 1 mg/l. The very high initial iron concentrations in the illustrated wells fell away rapidly as pumping progressed, reaching stable low levels within two hours in most cases. However, measurements in one well just three days after the test revealed that the initial iron concentration was as high as before the test, proving that accumulation of corrosion products from the pump was the major cause of high iron content.

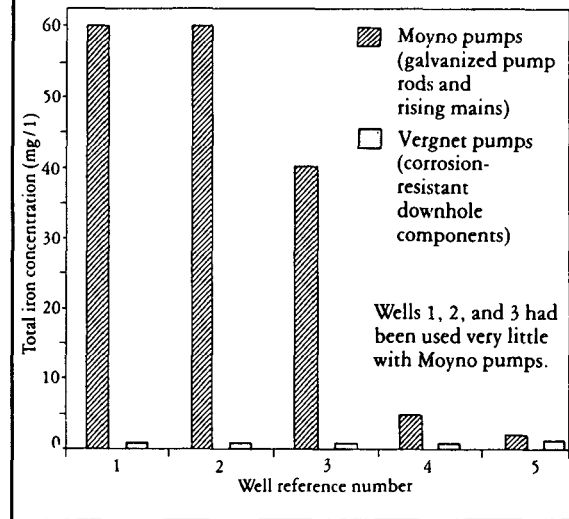
Figure 4.3B Changes in Iron Concentrations in Well Water due to Substitution of Corrosion-Resistant Pumps

sive. But, how do we recognize aggressive groundwater? Unfortunately there is no simple answer to this question. The first obvious step is to inspect any existing installations in the project area for evidence of corrosion.

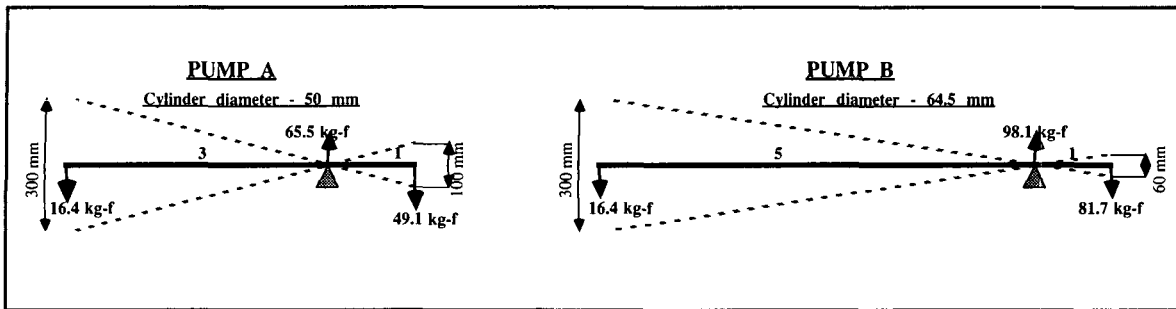
Box 4.4 Effects of Handle Design and Cylinder Size on Pumprod Stresses

Field trial observations have shown that users of lever-action handpumps tend to move the handle end by the same amount irrespective of the total stroke length available. This constant travel distance (usually in the range of 300 to 400mm) is maintained as long as the operating force is within acceptable limits. This finding has considerable significance for handpump designers.

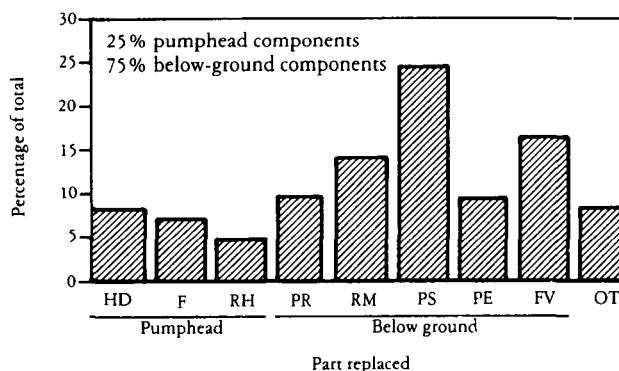
Repairs by Part Type

HD = Handle RH = Rod hanger RM = Rising main PE = Pumping element OT = Other
F = Fulcrum PR = Pump rod PS = Piston seal FV = Foot valve

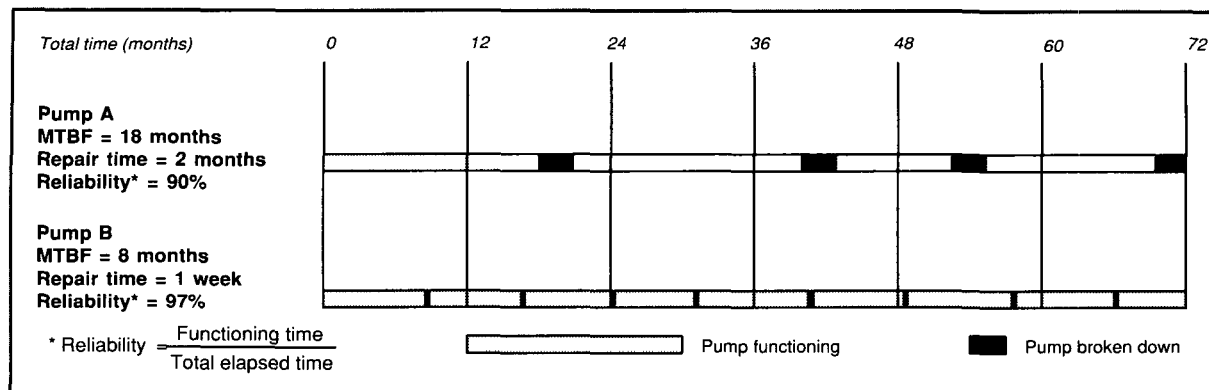
Box 5.2 Definitions of Reliability

The “*reliability*” of mechanical equipment is commonly measured in terms of the “mean time before failure” (MTBF). Thus, Pump A which has a MTBF of 18 months would be judged to be more “reliable” than Pump B for which the MTBF is 8 months.

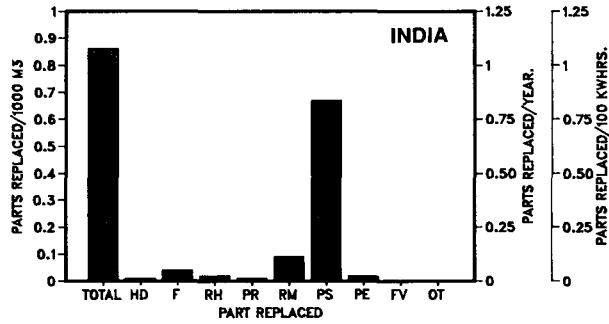
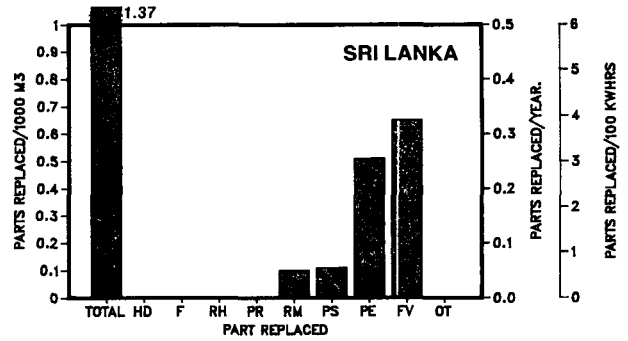
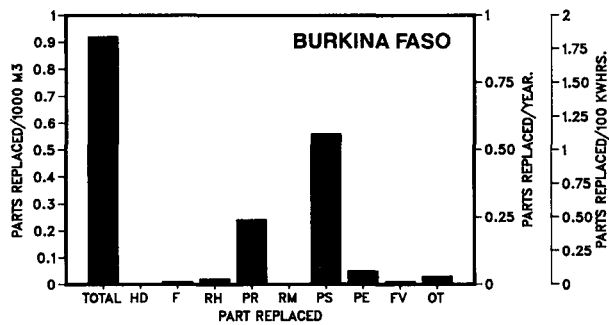
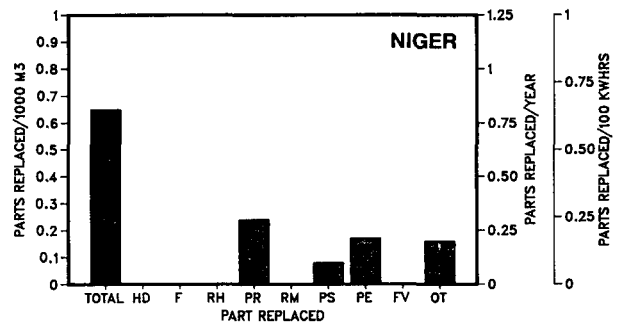
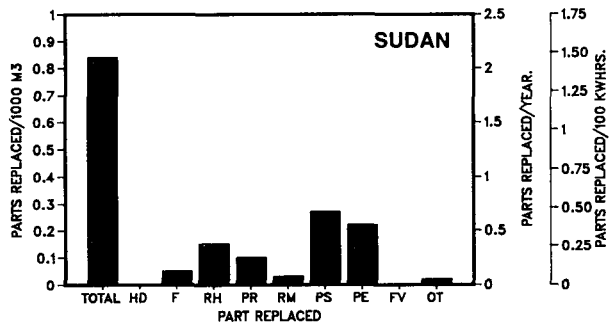
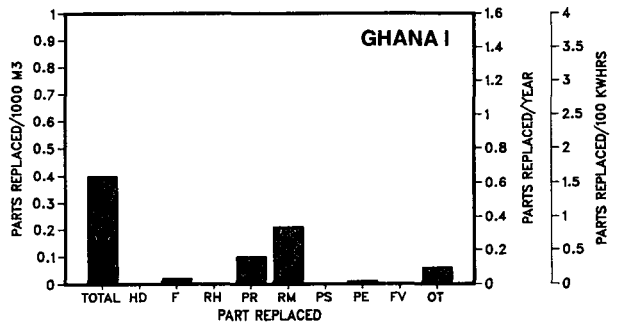
INDIA MARK II: CAUSES OF ESSENTIAL INTERVENTIONS

HD-Handle RH-Rod hanger RM-Rising main PE-Pumping element
 F-Fulcrum PR-Pump rod PS-Piston seal FV-Foot valve OT-Other
