# A handpump for Africa: the Afridev experience

by Michael Wood

**The Afridev pump is the result of a design and development process that began twenty years ago. It is now being manufactured in many different countries to a standard design, and the possibilities of local manufacture are being explored.**

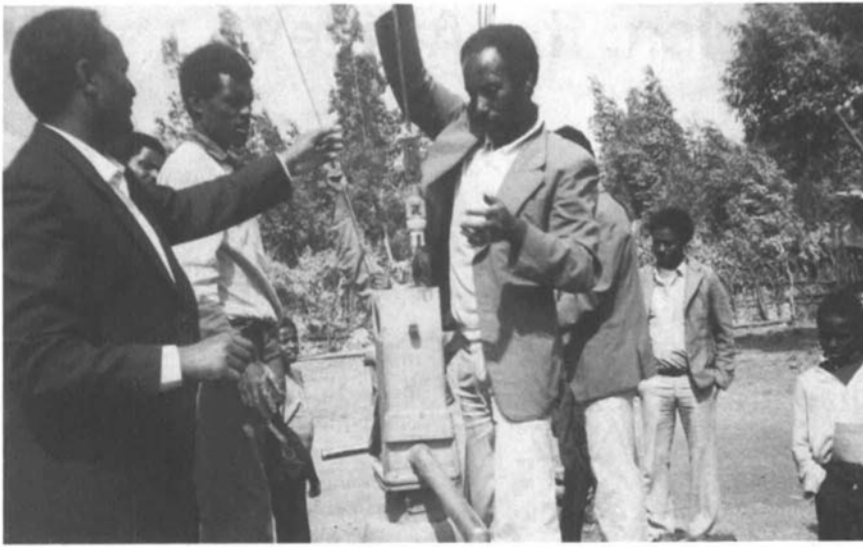
*A handpump caretaker learns how to remove a footvalve from an Ibex Afridev in Asgori, Ethiopia.*

so that parts could be replaced by hand, using snap-fits, and thus eliminating tools. So users can push in the nylon fulcrum and hanger bushes, and change the piston seal by pushing the old one off and rolling the new one into place over the piston. The rubber bobbins in the piston and footvalve can be removed and replaced by hand pressure alone. Some parts are interchangeable: the bushes can be used either on the fulcrum pin or the hanger pin; the piston or plunger can be used as a footvalve if inverted. Non-corrosive materials, such as nylon, nitrile rubber, stainless steel, and PVC are used in the Afridev.

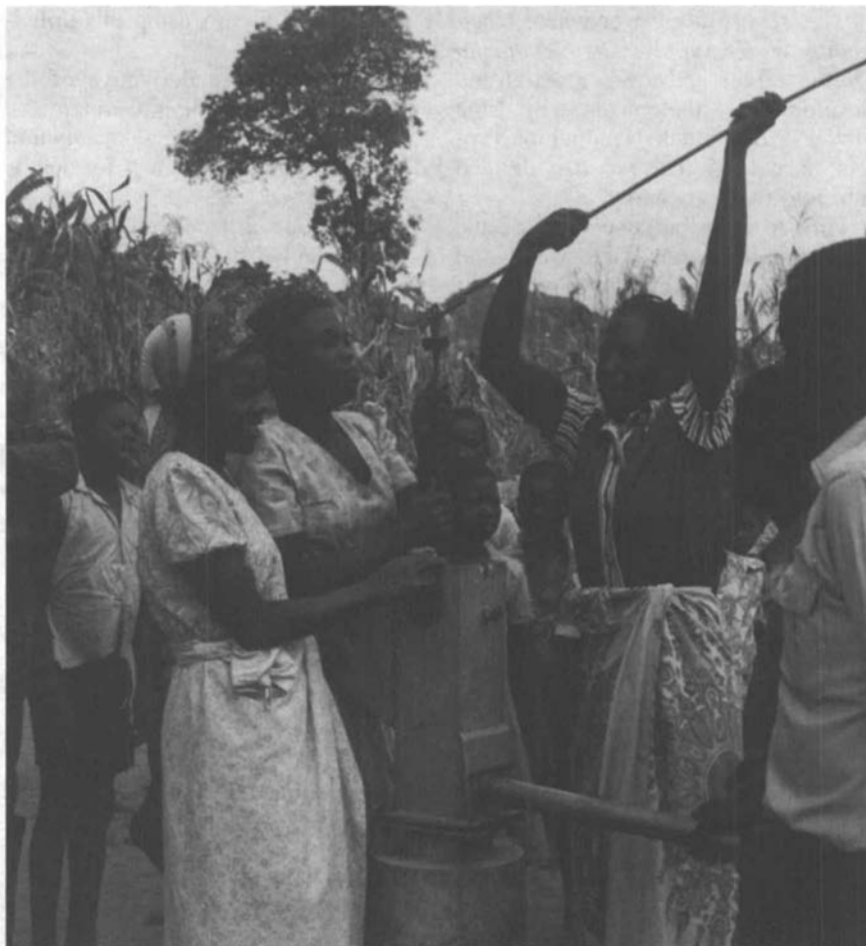
*Women caretakers removing the pumprods from an Afridev in Mali.*

One of the main design features of the Afridev is that the pump rods can be pulled out to change the piston seal and bobbin without having to remove the rising main. This eliminated the need for heavy lifting gear. The pump rods are designed with hook and eye connectors, so no tools are needed for dismantling. Another feature is that only one spanner is needed to install and maintain the pump, plus a small screwdriver or knife to change the piston seal. The pump was designed
